Triplett Creek Watershed Based Plan

Section One, Triplett Creek Watershed Based Plan, Project 08-07, #C9994861-08, Final

October 9, 2013

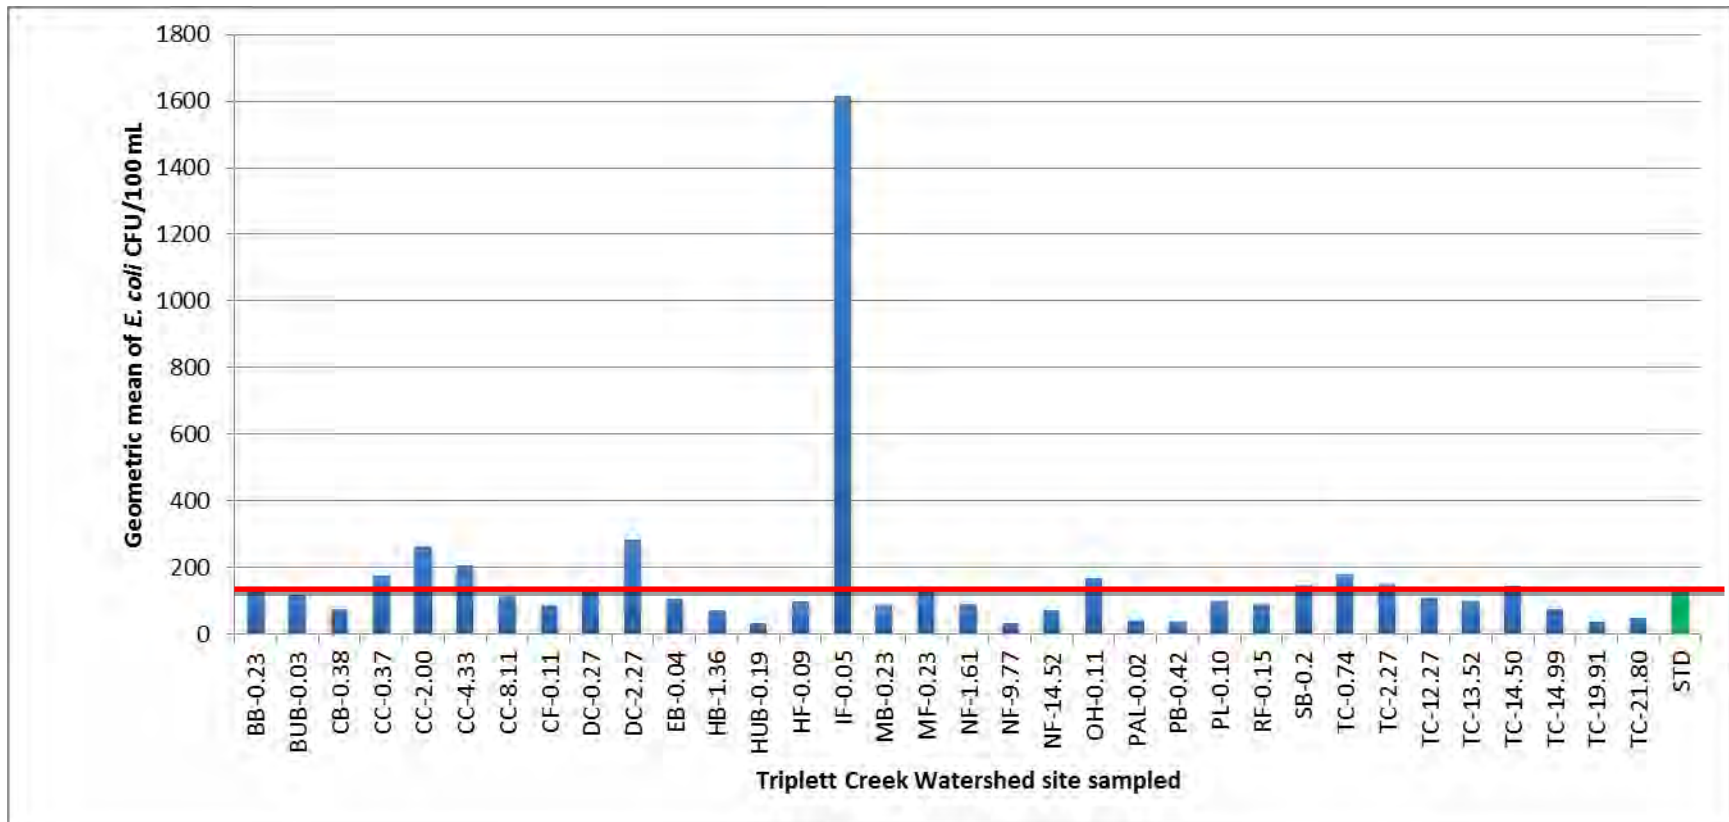
Figure 3.3. *E. coli* counts during the fall 2009 seasonal sample period. The counts represent geometric means of five samplings per site during the sampling period. The red line indicates the KDW limit of 130 *E. coli* CFU/100 mL (geometric mean; Standard (STD), green bar) for waters designated as primary contact recreation.

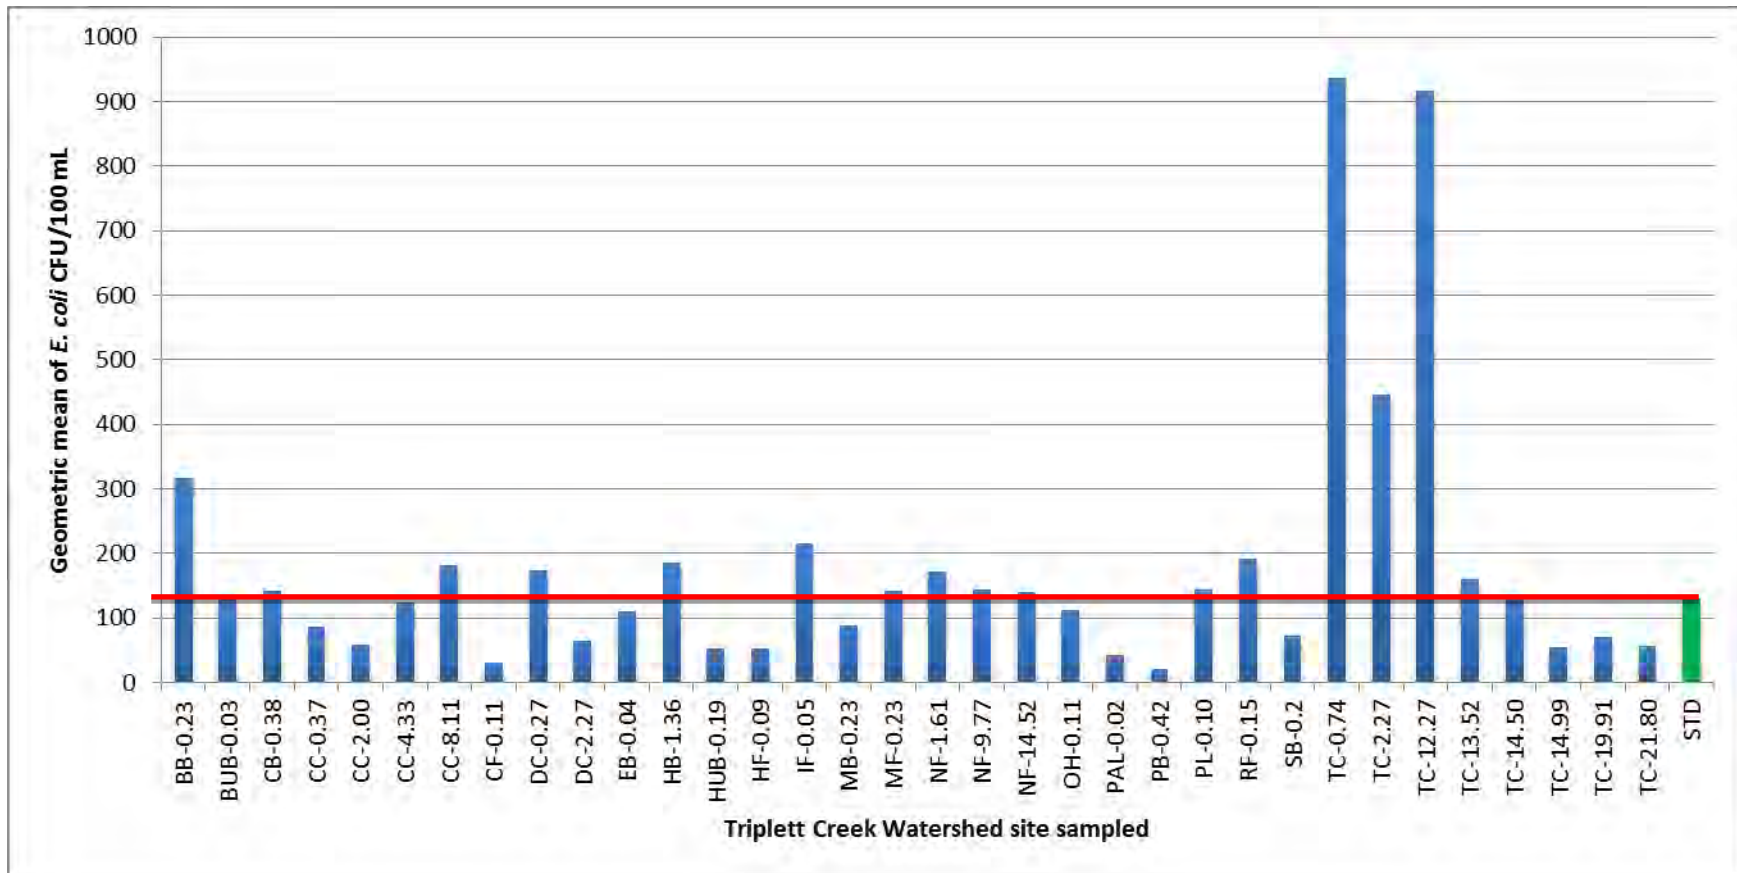
Figure 3.4. *E. coli* counts during the spring 2010 seasonal sample period. The counts represent geometric means of five samplings per site during the sampling period. The red line indicates the KDOW limit of 130 *E. coli* CFU/100 mL (geometric mean; Standard (STD) green bar) for waters designated as primary contact recreation.

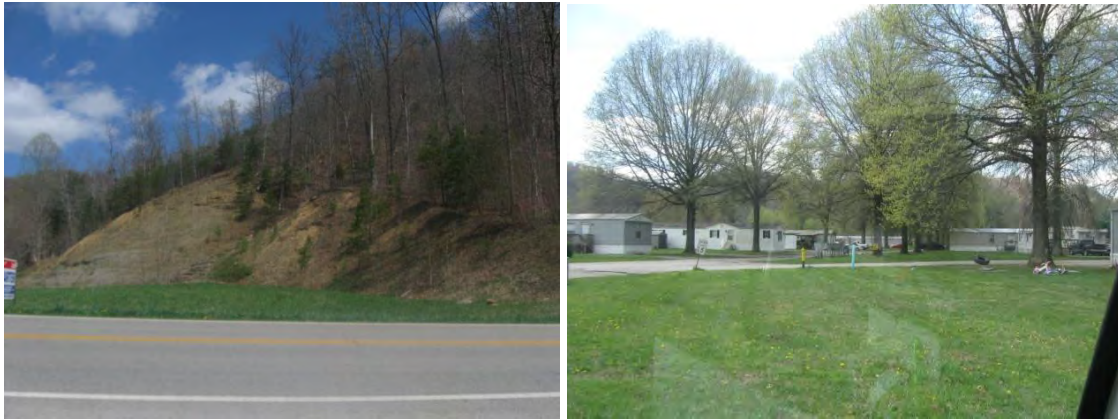
Figure 3.15. Photos from Christy Creek Watershed, CC-0.37.

The subwatershed of CC-0.37 is the most developed section of the Christy Creek watershed. The figures above are typical of the watershed. There several areas have exposed soils on the hillsides (figure on the left). The areas along the stream have a narrow row of trees and the hillsides are mostly forested. This is primarily a residential with rental units (figure on the right) watershed with some small patches of livestock. There is some commercial development (commercial rental property).

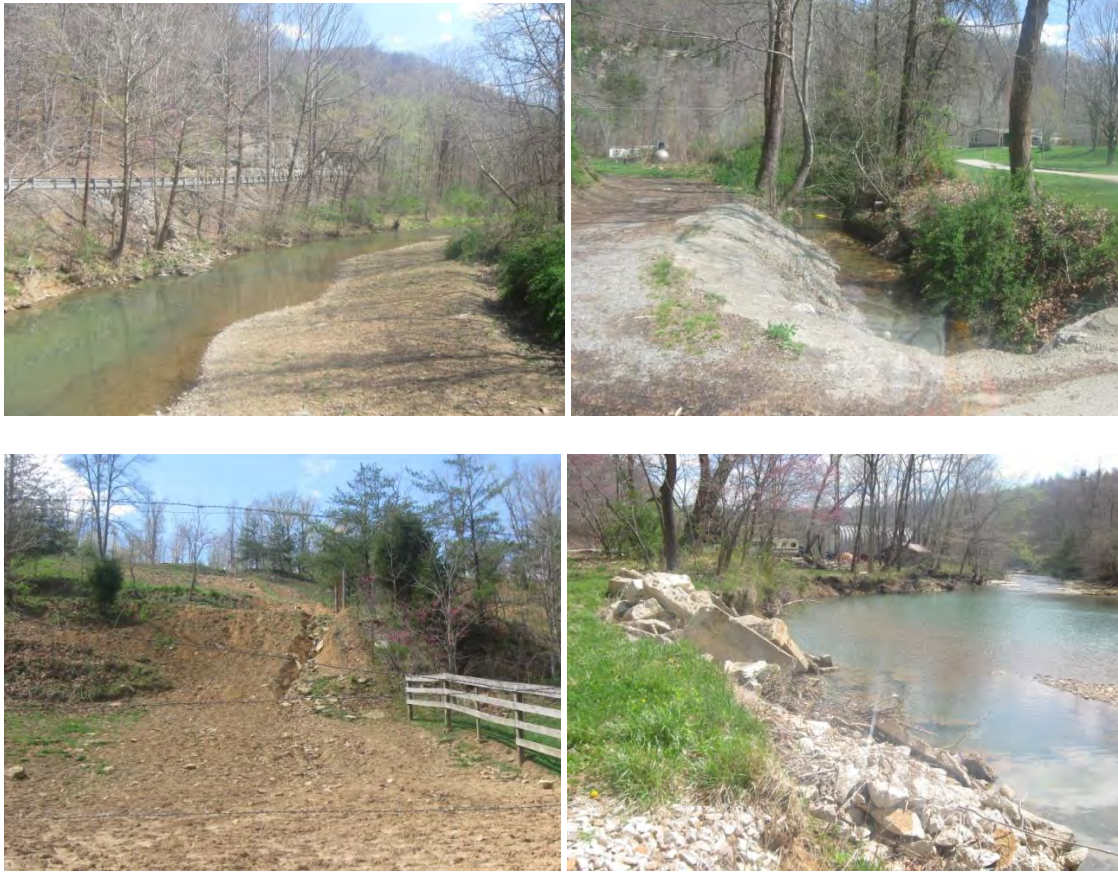
Figure 3.16. Photos from the Christy Creek Watershed, CC-2.00.

The subwatershed of CC-2.00 has little residential areas. The stream has been channelized through most of the section for agriculture, roads, and development. The streambank is severely eroding in several sections and have been ‘reinforced’ in several areas to protect the road and residential areas. There are several barren areas. The main stem Christy Creek only has a small strip of trees. The photo on the top right is an example of the channel straightening. The photo on the top right and bottom left show the streambank reinforcements and the strip of trees are exist along most of the main stem. The bottom left shows the exposed areas in the watershed. There are a few small businesses in this watershed (car lot, greenhouse, junk yard)

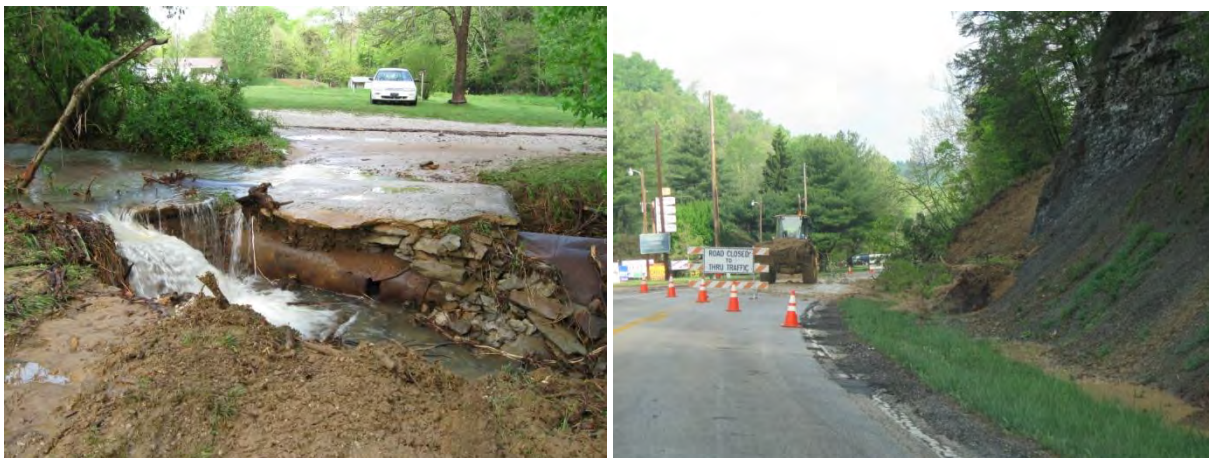
Figure 3.49. Examples of large wash outs of sediment during heavy rain events. The photo on the left is private drive that crossed a minor tributary of Christy Creek near CC-2.00. The photo on the right is a hillside on HWY 32 near the bridge that crossed Triplett Creek.

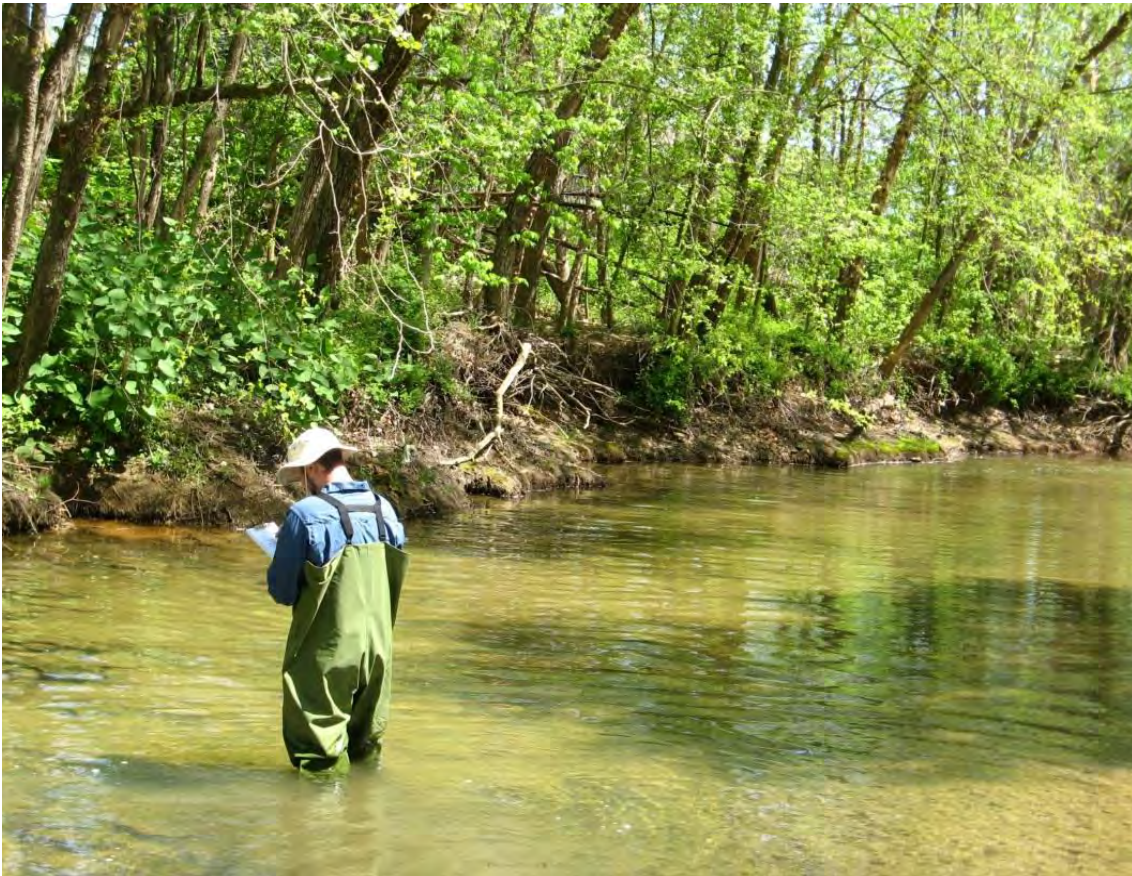
Figure 3.50. Example of a streambank with low erosion risk (MBEHI = 10.3).

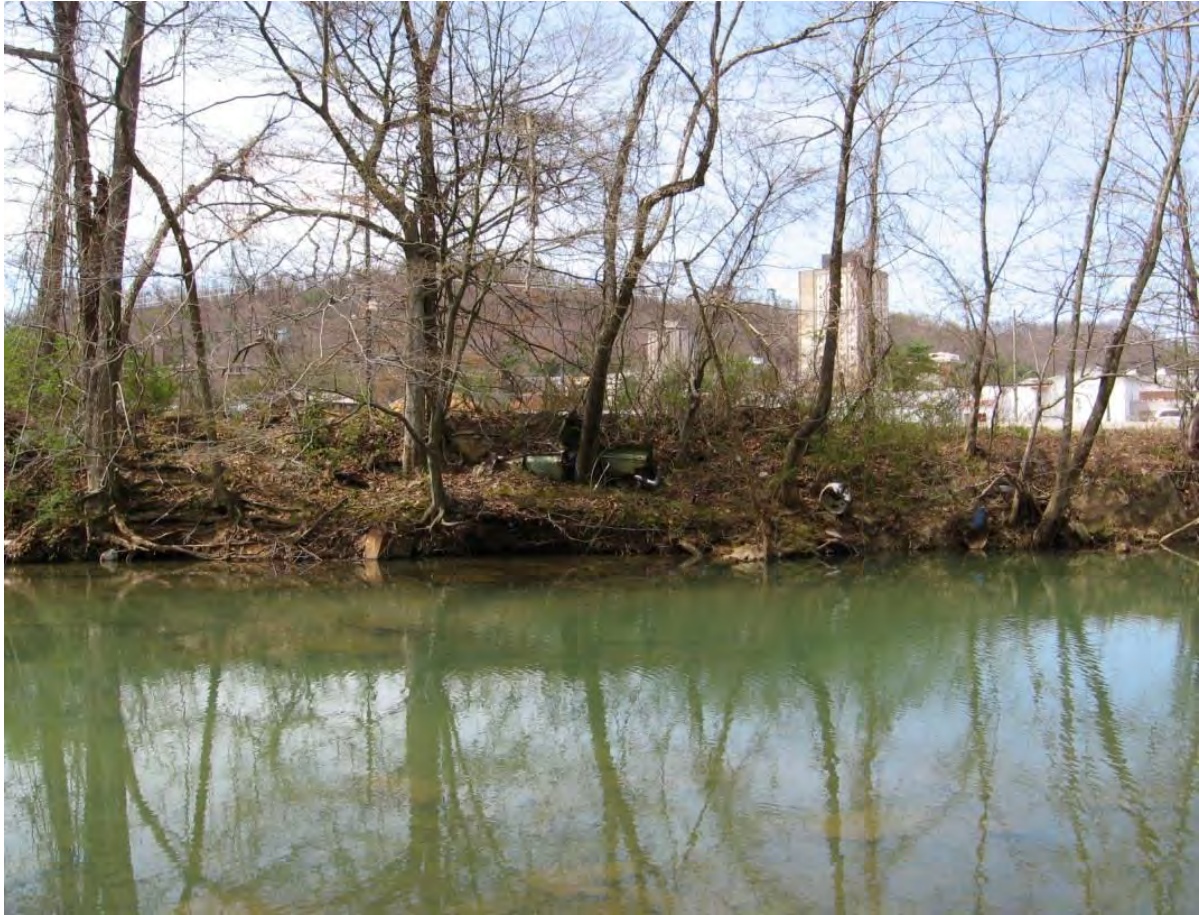
Figure 3.51. Example of a streambank with moderate erosion risk (MBEHI = 17.8).

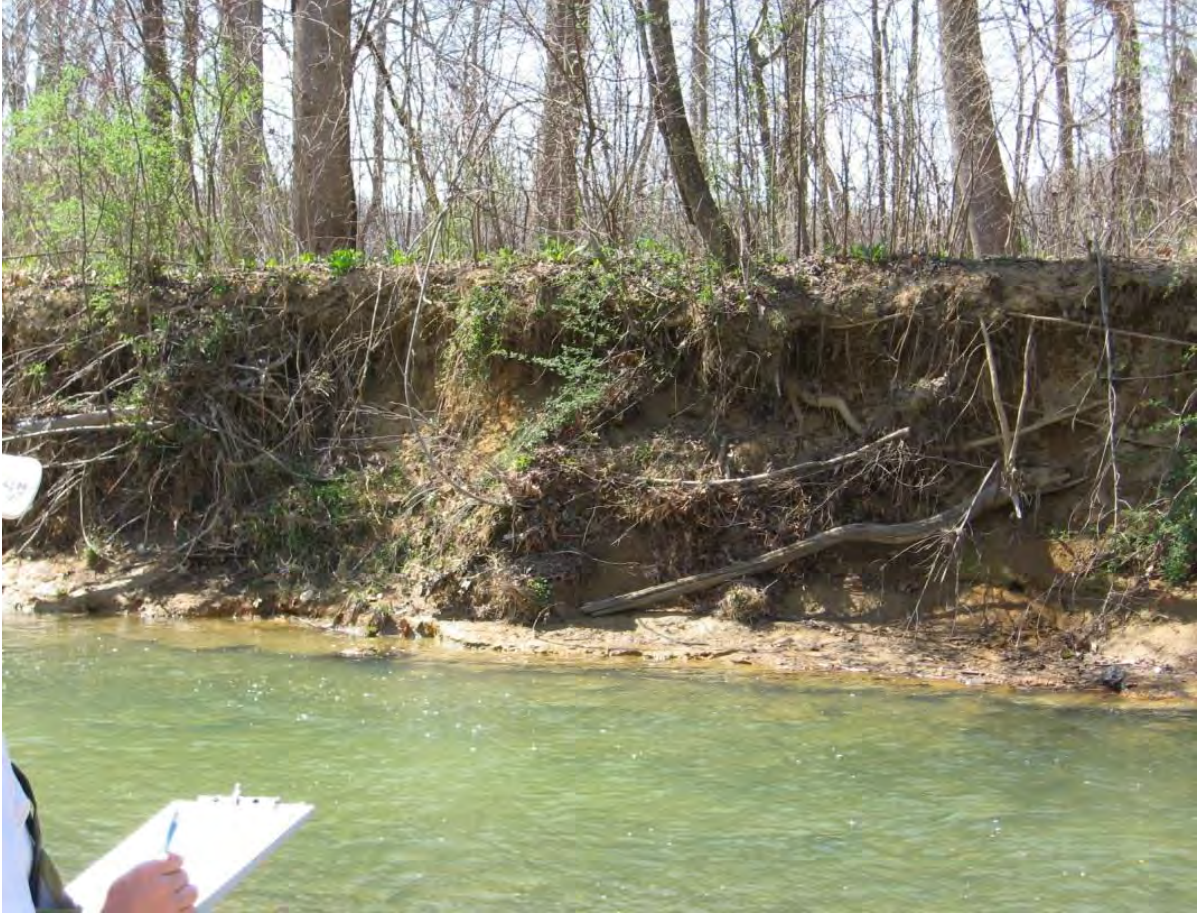
Figure 3.52. Example of a streambank with high erosion risk (MBEHI = 21.8).

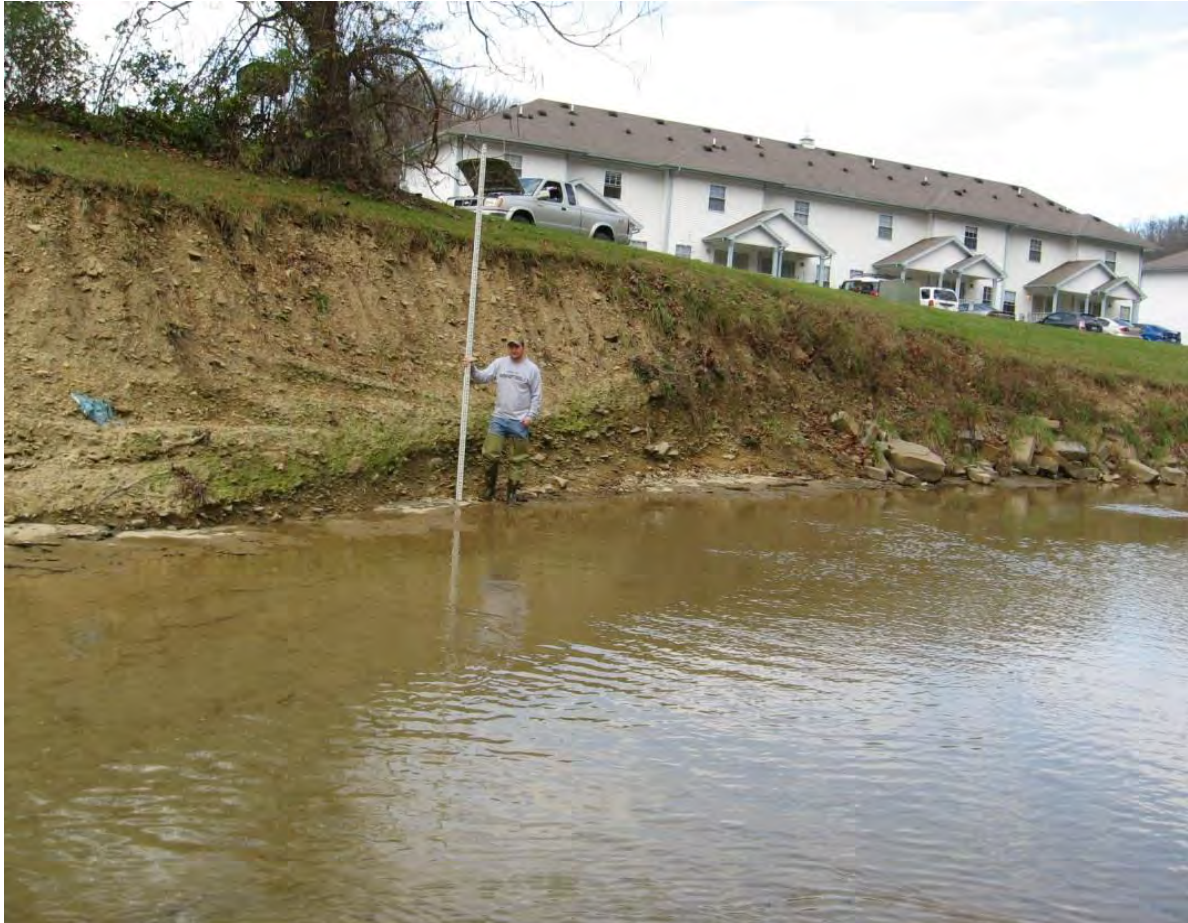
Figure 3.53. Example of a streambank with extreme erosion risk (MBEHI = 35.0).

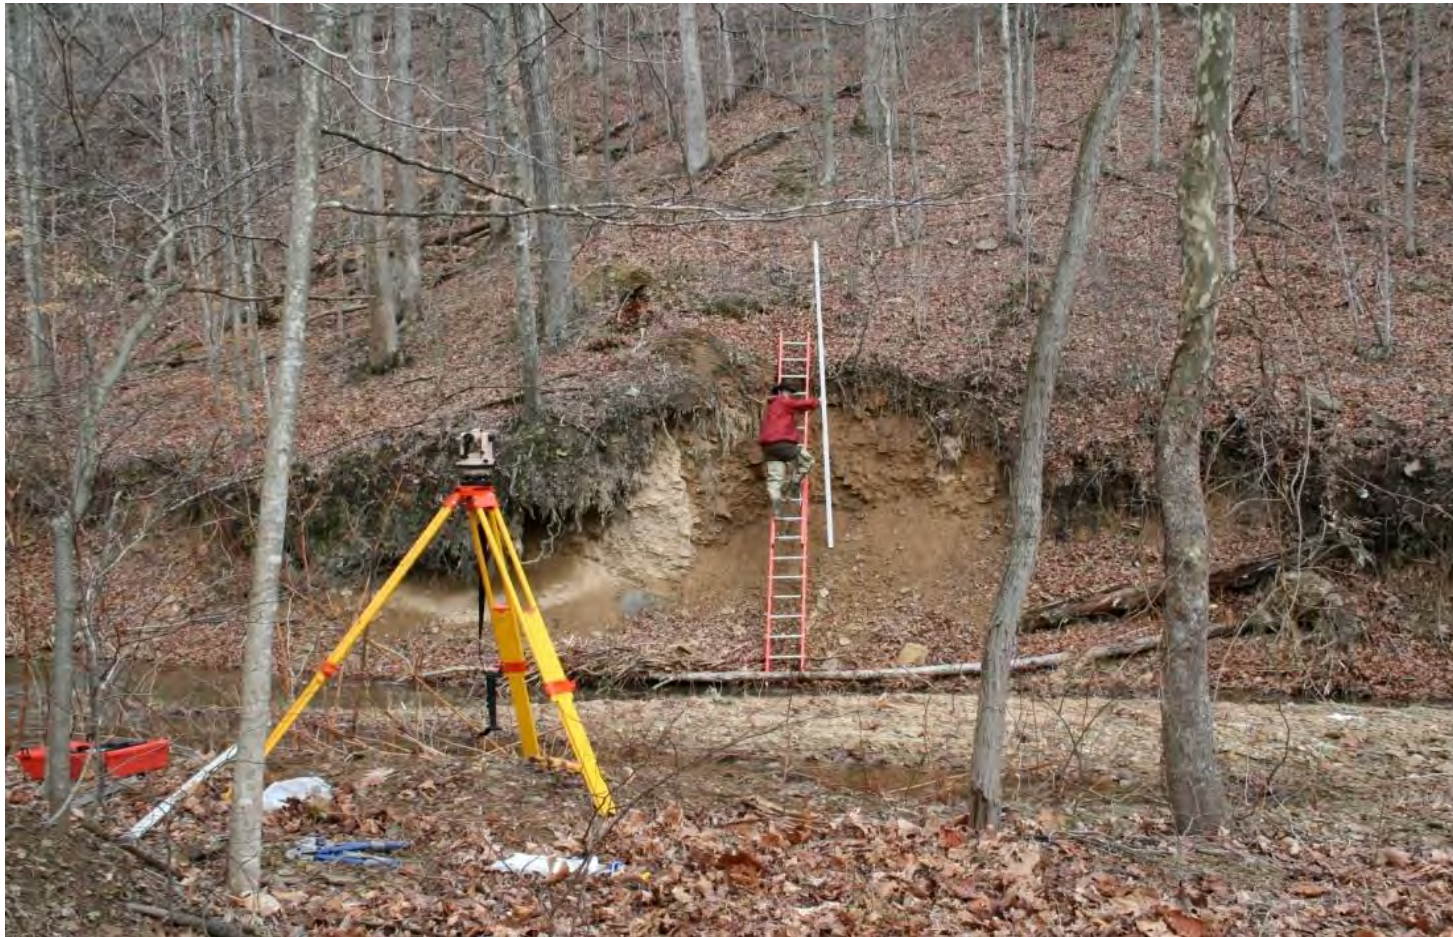
Figure 3.54. Measurement of channel cross-section between fixed end points (4 ft rebar monument pins).

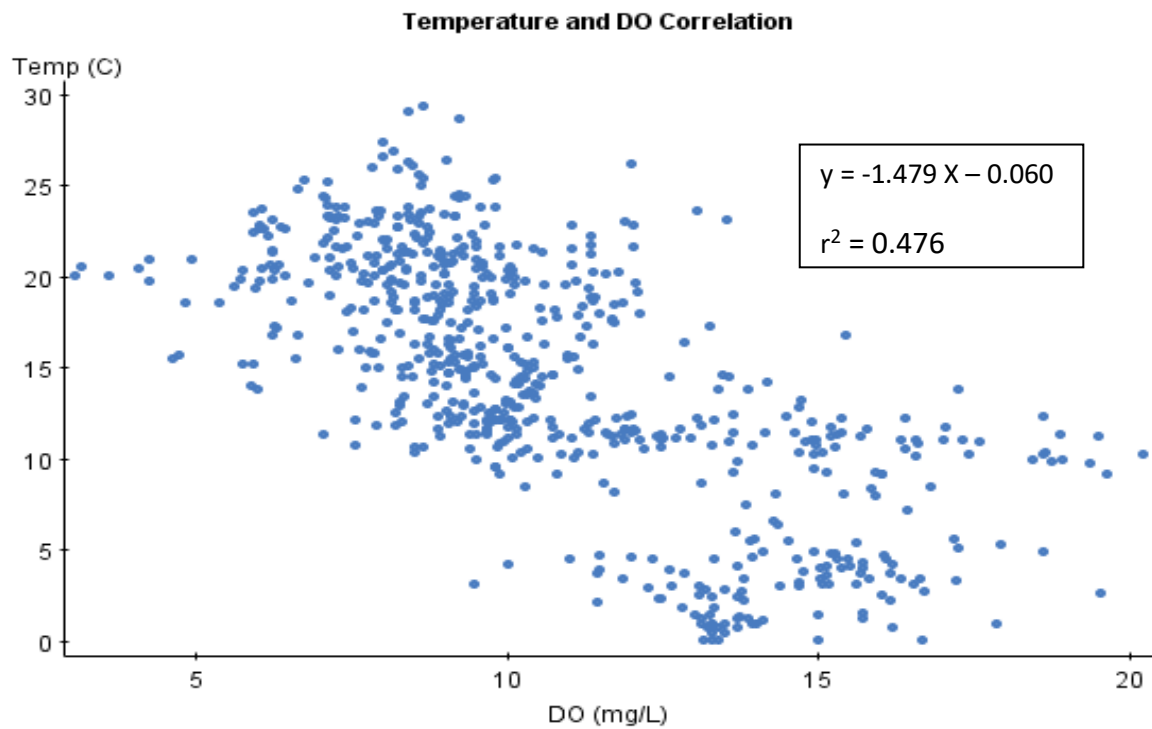
Figure 3.60. Relationship between temperature and dissolved oxygen.

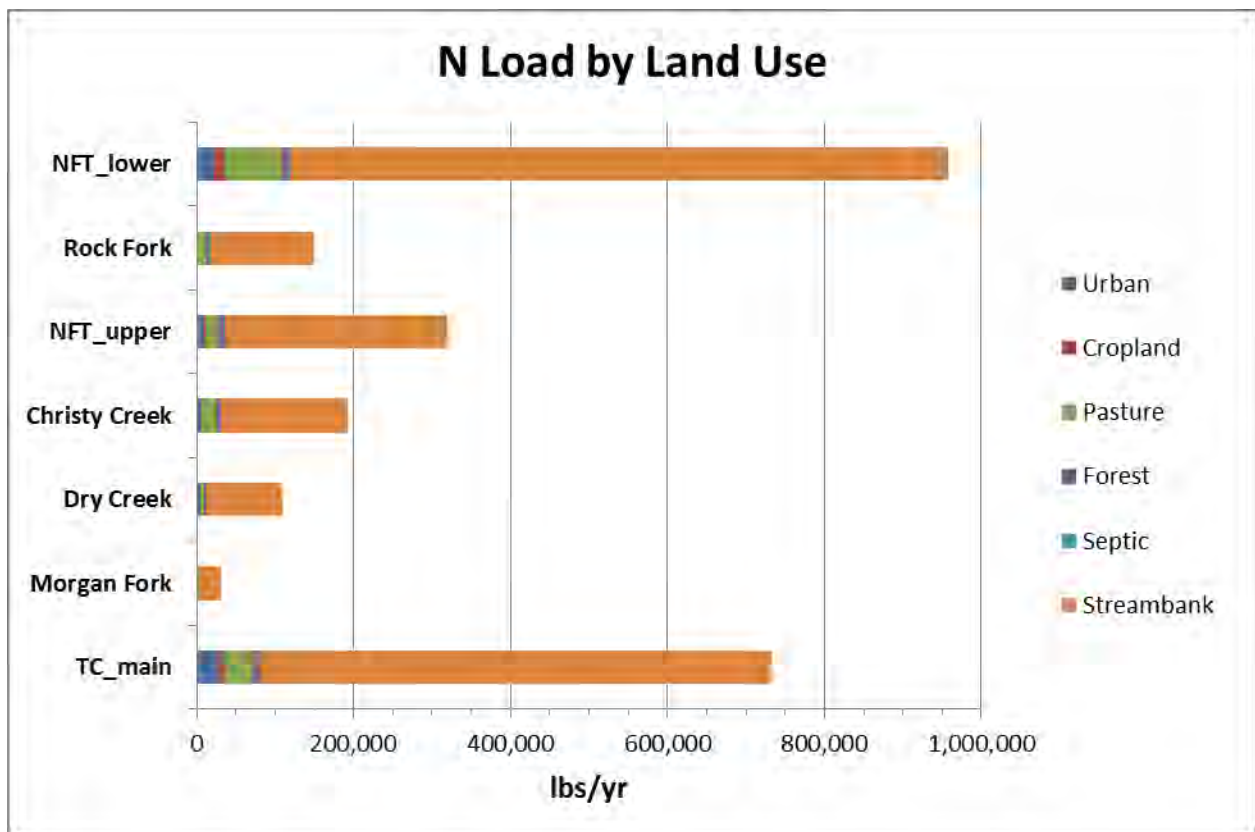
Figure 3.62. STEPL predicted nitrogen (N) load by subwatershed and land use.

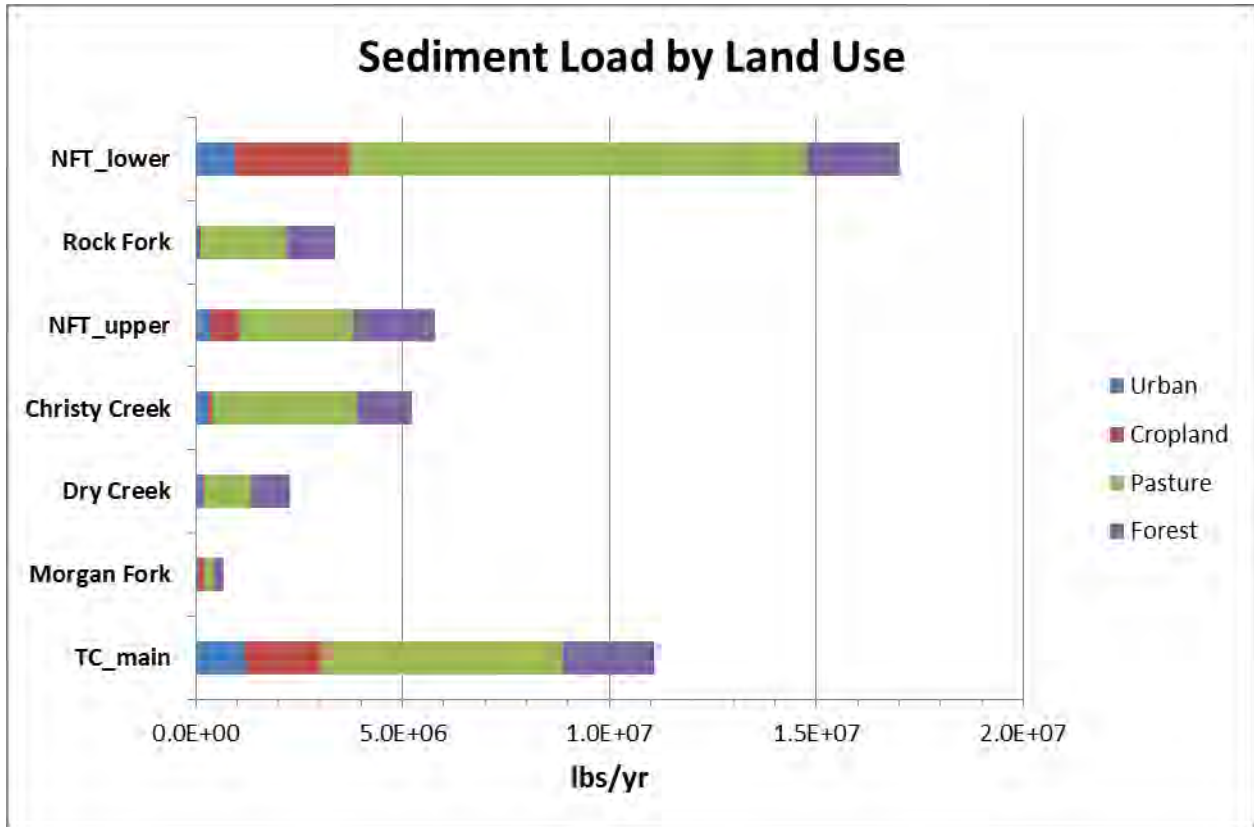
Figure 3.64. STEPL predicted sediment load by subwatershed and land use – except ‘streambank’ (see Figure 3.66).

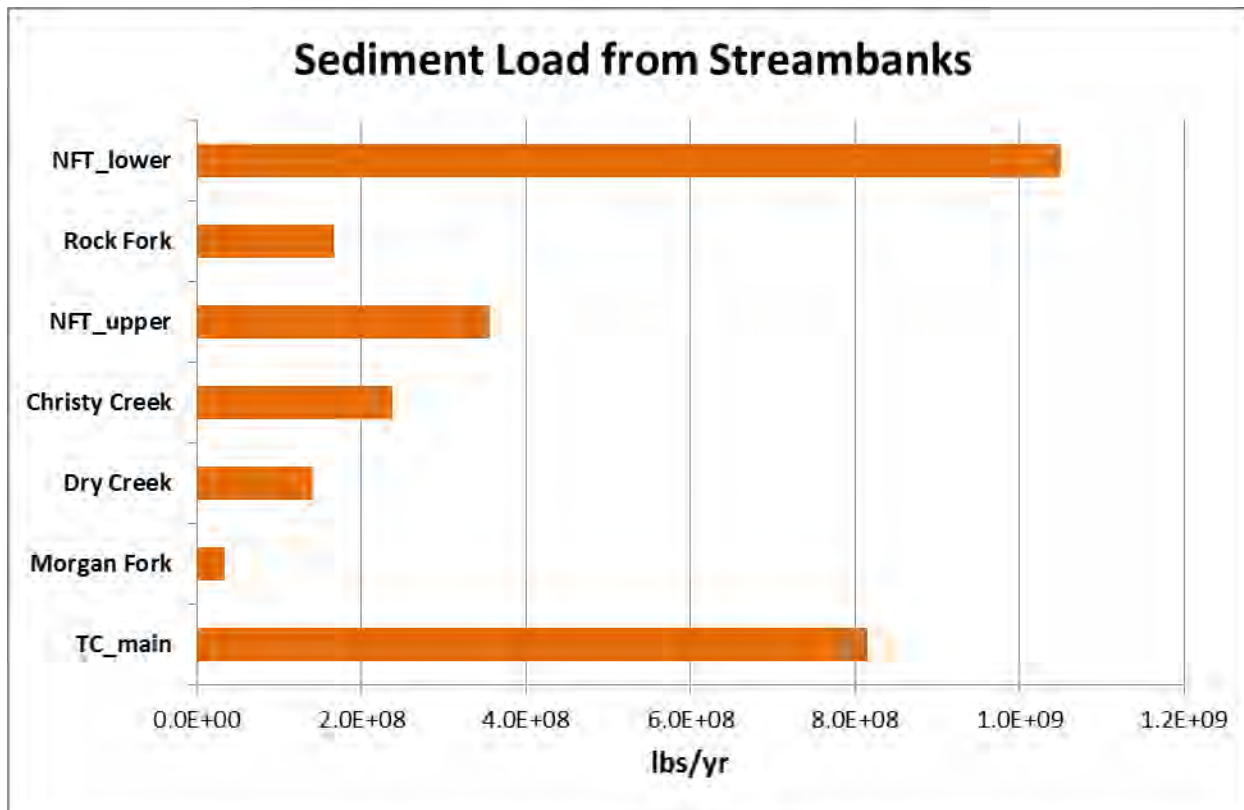
Figure 3.65. STEPL predicted sediment load by subwatershed for the streambank land use.
