# Wolf Run Watershed Based Plan

Lexington, KY

Final, March 1, 2013

Third Rock Consultants, LLC  
Steve Evans, Chelsey Olson, Jennifer Shelby  
2526 Regency Road, Suite 180  
Lexington, Kentucky 40503  
859-977-2000

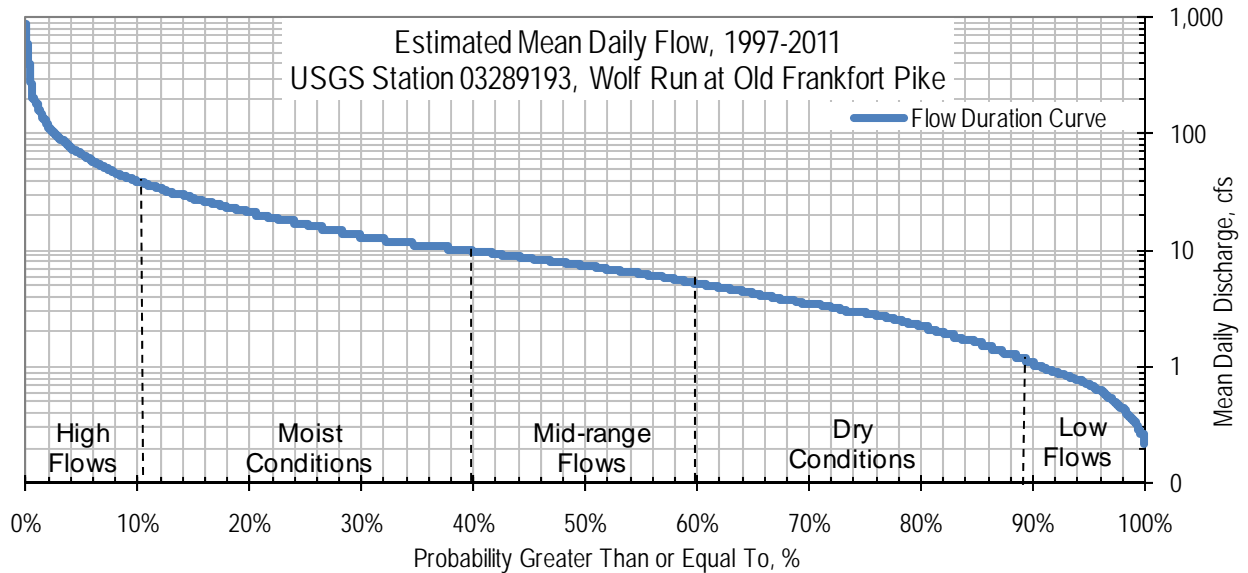
**FIGURE 1 – WOLF RUN AT OLD FRANKFORT PIKE, MEAN FLOW STATISTICS**

A United States Geological Survey gaging station was established on Wolf Run near Old Frankfort Pike in September 1997. Basic statistics on the discharge at this station are provided in Figure 1. These statistics indicate that Wolf Run discharges approximately 0.1 to one cubic foot per second (cfs) under low flows, one to four cfs in dry conditions, four to 10 cfs in mid-range conditions, 10 to 30 cfs under moist conditions, and 30 to 893 cfs in high flows.

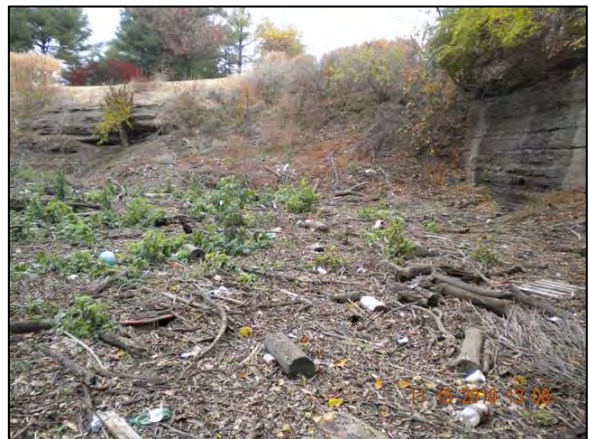
*Debris Accumulation at Picadome Sinkhole Prior to Cleanup*

There are 19 significant trash and debris sites noted watershed, as shown in Exhibit 22, page 58. Of these, six are woody debris locations and the rest have varying amounts and types of trash. Volunteer groups could pick up most of the trash although local government would be necessary to remove large trash and debris in some areas. A contractor was hired by LFUCG to remove a large amount of debris from the Picadome sinkhole during 2011.

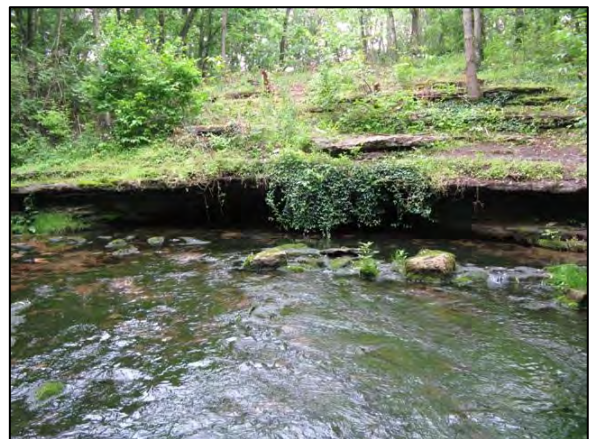
*Preston's Cave, a Unique Geological Feature*

McConnell Branch (W2), which receives most of its flow from Preston's Cave and the upstream McConnell Springs groundwater sources, exhibits modulated hydrology due to the karst drainage. Banks within this reach are relatively stable and not actively eroding. In fact, in-stream deposition and aggradation seems to be more negatively impacting aquatic habitat than erosion. The stream is likely over-widened and thus does not have the capacity to transport the current sediment load. Though this reach is shaded by riparian vegetation, algal growth was observed throughout the reach during 2012 monitoring. Additionally, the riparian vegetation contains non-desirable invasive species and the riparian zone would benefit from invasive species removal/management and establishment of site-specific, native vegetation. Stakeholders indicate that the observed sedimentation at this site may be a result of prior disturbance and fill rather than ongoing sediment transport to the reach. The median

particle size in active riffles is medium to coarse gravel. Additional study and design calculations could be used to evaluate what the current sediment load to this stream is (though complicated by the karst drainage) and whether modifications to the channel dimensions and profile could increase sediment transport capacity of the stream in order to alleviate the embedded substrate and sedimentation observed here. This reach has more pattern and more desirable vertical diversity of the streambed, with rather deep pools being measured by the longitudinal profile survey. This reach is an attractive recreational segment accessed by the public on an adjacent trail. Improving the riparian vegetation and sediment transport/aquatic habitat

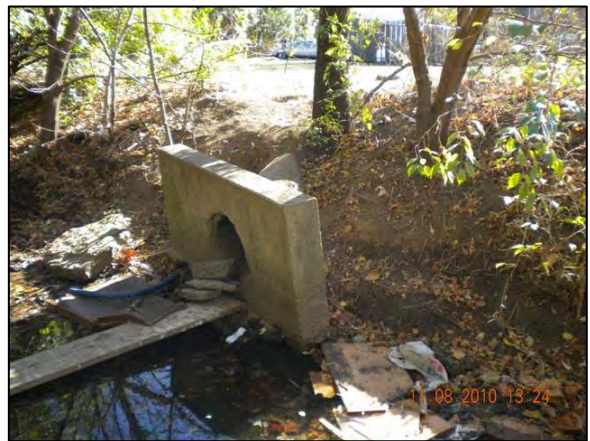
The reach represented by this site is the most downstream portion of Vaughn's Branch, just upstream of its confluence with Wolf Run. As observed during the longitudinal profile survey and as indicated by the habitat assessment data, there is a relatively frequent occurrence of riffles in this section of stream, which provides aquatic habitat, but visible bank erosion, lack of bank cover, and low riparian width reduce the stability and quality of this reach. A severe erosion area is located in this reach near the confluence with Wolf Run and has impacted infrastructure (utility pole, stormwater outfall). The longitudinal profile indicated a deep pool on bedrock and the remainder of the reach was predominately riffle and run habitat. The median particle size in active riffles is coarse gravel. The vertical diversity could be enhanced to create more niche habitats for aquatic life. Improvement to this section of Vaughn's Branch could focus more on creating a stable stream cross-section, which would stabilize the stream banks, and increasing riparian width and quality. The public frequently crosses Vaughn's Branch in the downstream portion of this surveyed reach. This contributes to frequent trash dumping within this reach. If the water quality and physical stream condition were improved, it would be a good location to re-connect the public with their water resources.

*Erosion and Infrastructure Damage at Vaughn's Branch Mouth*

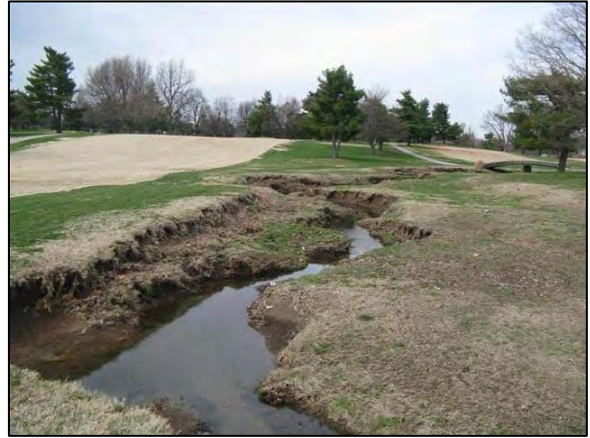
*Erosion on Vaughn's Branch on Picadome Golf Course*

This reach, within Picadome Golf Course, also has a strikingly low habitat assessment score, with very low availability of stable substrate, high indication of substrate embeddedness and in-stream deposition, evidence of eroding banks and little bank protection, and a riparian corridor highly modified by landscape maintenance activities and removal of all streamside, rootwad-producing vegetation. This reach shows numerous areas of severe erosion. Due to its location within LFUCG park property, restoration of stream dimension, pattern, profile, and riparian zone is feasible in this reach if changes to the golf course are acceptable. This is a very public location to showcase a successful stream restoration project and re-connect the public with their water resources. For this reason, this reach has been identified as a priority restoration area.

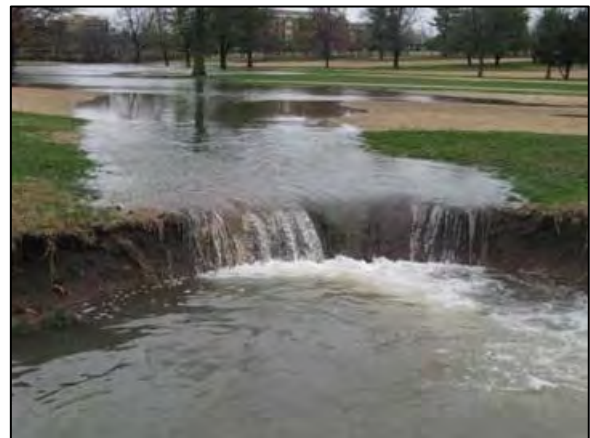
*Stream Flow and Erosion across Fairways from Big Elm Tributary to Vaughn's Branch*

Big Elm tributary contributes flow to Vaughn's Branch within the golf course. However, there is not a stream connecting the two reaches. Under base flow conditions, all of the flow from the Big Elm tributary flows into a large sinkhole. Under flood conditions, the stream flow exceeds the capacity of the sinkhole and floodwater flows across the fairways to Vaughn's Branch. The absence of a channel connection from Big Elm tributary to Vaughn's Branch causes erosion as well as deposition of large debris subsequent to storms. This could be remedied by restoration of the channel, though it will impact play at the golf course and require careful planning.

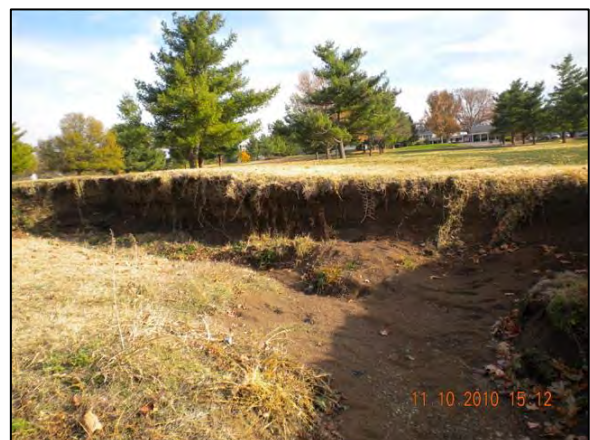
*Severe Erosion on Big Elm Tributary near Picadome Sinkhole*

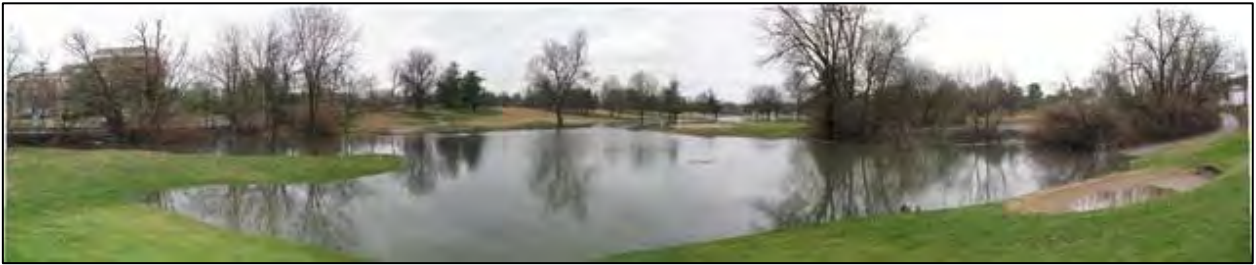
*Panorama of Flood Waters at Confluence of Big Elm Tributary and Vaughn's Branch*

In addition to quantifying the degree of flashiness in the watershed and the range of flows measured on the tributaries to Wolf Run, the study helped to clarify the relationship between surface and karst groundwater flows, particularly under storm conditions at the confluence of the Big Elm Tributary and Vaughn's Branch. The study found that as the karst conduit's flow capacity is maximized, through upstream inputs such as Wolf Run at Southbend Drive or through the maximized capacity at the spring outlets (McConnell Springs), water begins to back up at the Picadome sinkhole until flood levels are sufficient to allow for the bypass across to Vaughn's Branch. Under these conditions, almost the entire flow from the Big Elm Tributary enters Vaughn's Branch. Once the groundwater system has additional capacity to accept additional flow input, floodwaters begin to decline at the Picadome sinkhole. These multiple inputs into the karst system cause higher flow levels at McConnell Branch to be sustained for longer periods of time while also suppressing the peak flows and lengthening both the rising and falling limbs of the hydrographs in the headwater areas of Wolf Run and the Big Elm Tributary.

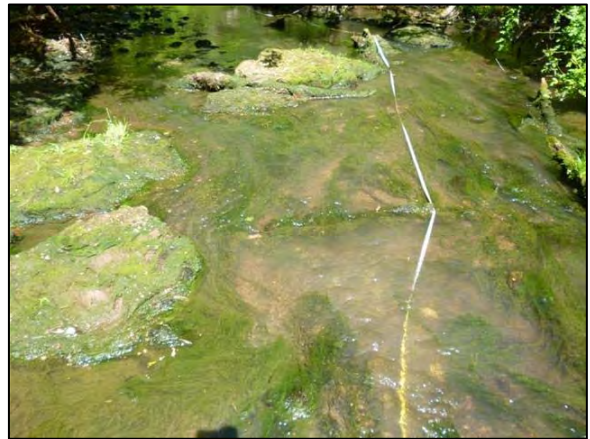
Abundant algal growth was observed at multiple areas across the Wolf Run Watershed as identified in Exhibit 28, page IV-16. This algal growth is caused by excessive nutrient loading and lack of stream shading and causes low dissolved oxygen levels and high pH. Aquatic plants and algae, which produce oxygen during the day through photosynthesis, consume dissolved oxygen after sunset, when no photosynthesis occurs. If a large volume of aquatic plant material is present in the stream, the plants may use so much dissolved oxygen that conditions toxic to aquatic life are produced at night. Additionally, abundant decaying plant matter leads to excessive oxygen use during bacterial decomposition. Fish require at least 5 to 6 mg/L of dissolved oxygen for normal activity. Levels below 4 mg/L are stressful, and levels below 2 mg/L are lethal. No fish kills were known to occur during the monitoring period.

*Significant Algal Growth on McConnell Branch*

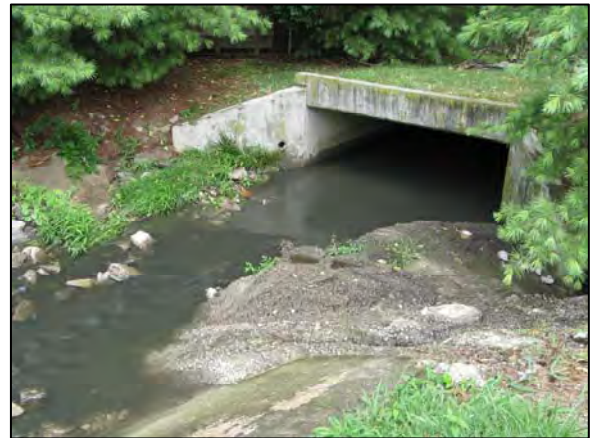
Total suspended solids were, as expected, higher in wet weather events than during dry and intermediate events. Sites W01, W03, W04, W09, and W10 each had suspended solid levels exceeding 80 mg/L with a high of 200 mg/L measured at W10 on October 13. All of these elevated events occurred during wet events. During wet weather events with high concentrations of suspended sediment, the color of the water is typically black or gray rather than brown like the soil color. Although erosion is a contributor to the suspended sediment load, the color of the turbidity indicates that stormwater runoff is a greater contributor to suspended sediments in Wolf Run.

*Grey Colored Stormwater on Vaughn's Branch  
Upstream of Picadome Golf Course*

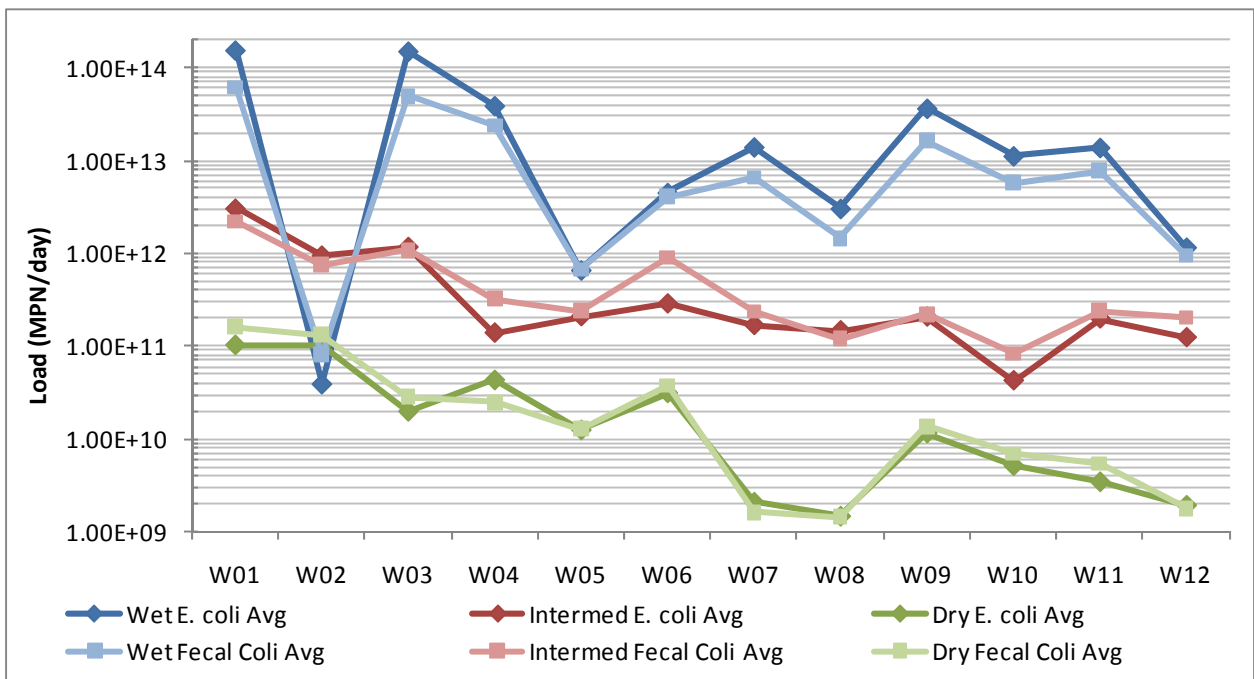
FIGURE 6 – DAILY *E. COLI*/LOADING BY EVENT TYPE

Table 31, page IV-27, indicates the load reductions necessary to achieve the PCR standards of 130 and 240 MPN/100 mLs during all weather conditions. A reduction of over 90 percent is required at all sites in the watershed in order to achieve these results (87.9 percent at W05 is the lowest reduction to achieve the instantaneous standard). For most sites, over 70 percent of the loading comes in wet weather conditions and at some sites (W04, W09, W10), 98 percent of the loading is due to wet weather. The loading for W02 is more evenly distributed across dry and intermediate conditions while W05 has nearly equal loading due

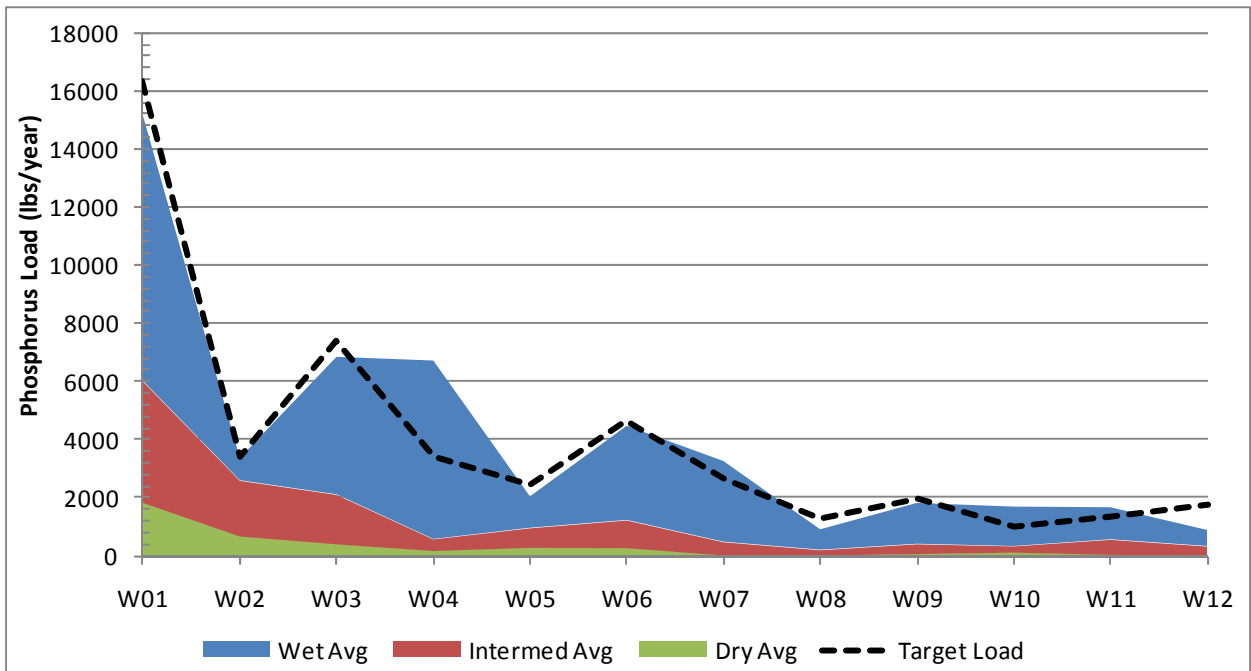
**FIGURE 8 – ANNUAL TOTAL PHOSPHORUS LOADING CONTRIBUTIONS BY EVENT TYPE**

\*Target load based on 0.35 mg/L non-regulatory reference point.

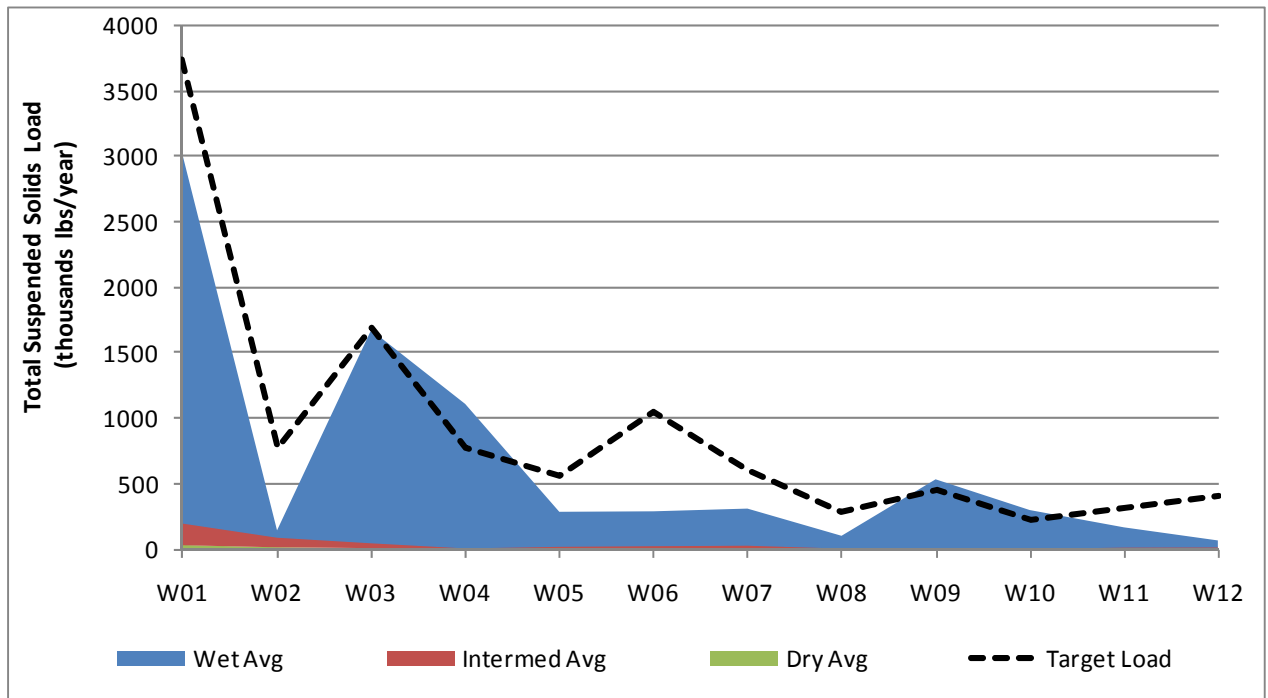
FIGURE 9 – ANNUAL TOTAL SUSPENDED SOLIDS LOADING CONTRIBUTIONS BY EVENT TYPE

\*Target load based on 80 mg/L non-regulatory reference point.

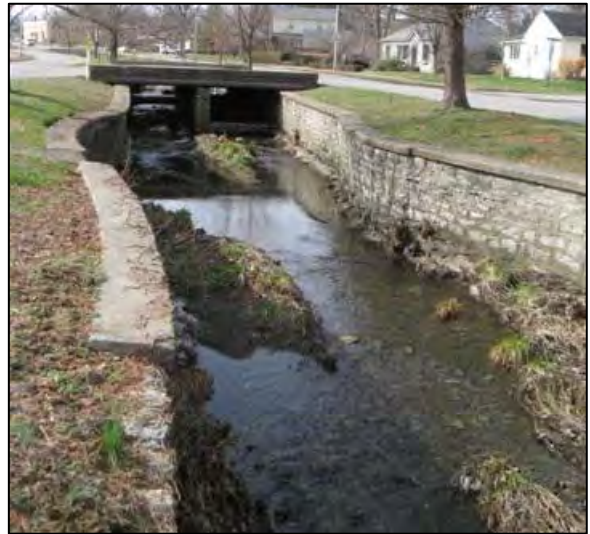
The encroachment of development into the floodplain and riparian zone of some streams within the Wolf Run Watershed have rendered restoration of certain reaches unfeasible due to the high cost involved with the acquisition of property and stream and floodplain restoration. Specifically, over 4,300 feet of Wolf Run upstream of Clays Mill Road is either located within a concrete channel or has stone armored banks. Much of this reach is also located between roadways or shopping centers. These urban constraints limit the restoration options for these reaches and make restoration very difficult; thus, stream restoration is considered unfeasible for these reaches. Green infrastructure to contain stormwater onsite and reduce runoff volumes is considered a more feasible BMP in this area.

*Armored Banks on Wolf Run at Lafayette Parkway*

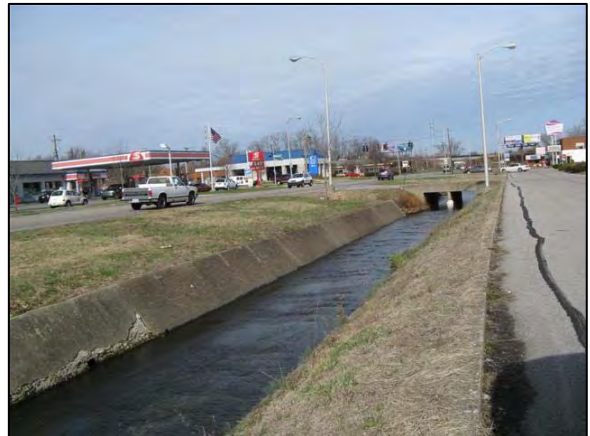
*Wolf Run, Concrete Channel Beside Southland Drive*
