Hancock Creek Watershed Plan

The Hancock Creek Watershed Plan (WP) outlines all point and nonpoint pollution sources in the watershed, quantifies the pollution coming from each source, and makes recommendations for Best Management Practices (BMPs) to improve water quality in Hancock Creek.

Hancock Creek is a tributary of Strodes Creek and located in the Licking River Basin. The Hancock Creek watershed is a 12.96 square mile (8,295 acres) area located in Clark County.

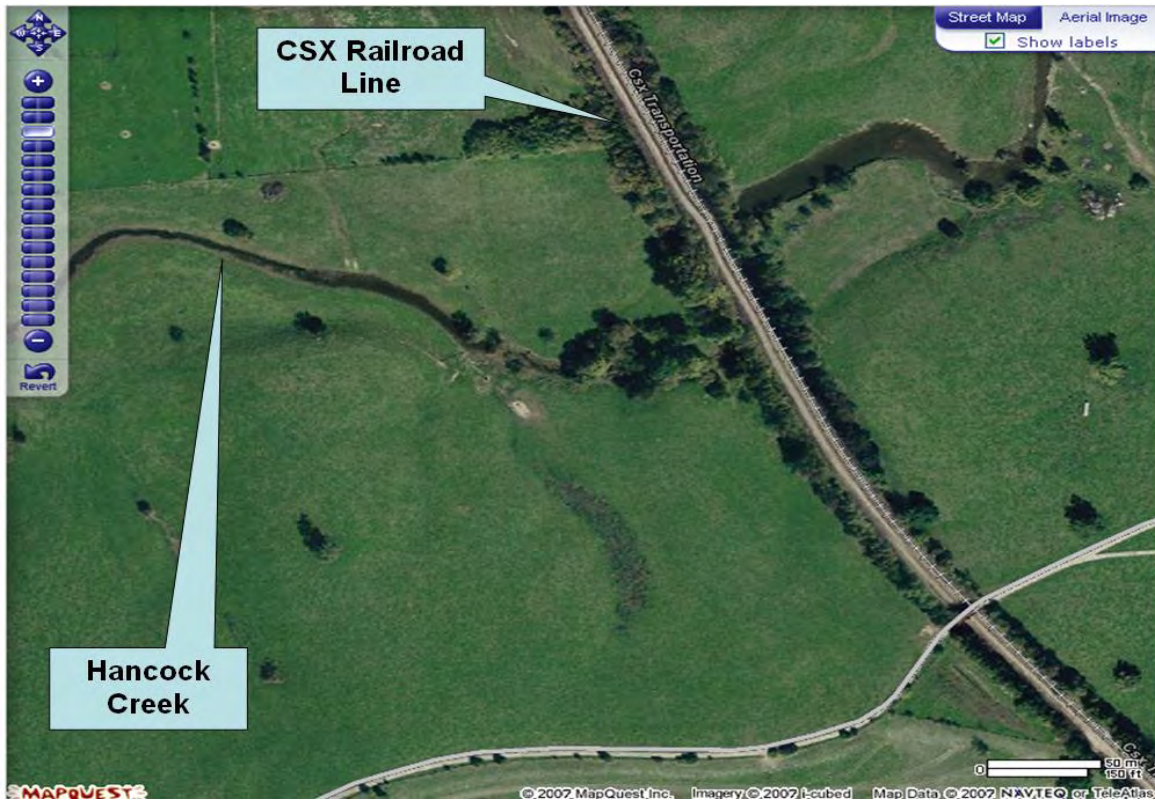
Figure 2.6. Section of Hancock Creek near confluence with Strodes Creek showing lack of vegetative cover along channel typical of most stream reaches in the watershed. Source: Tetra Tech, 2008.

In terms of stream channel issues, it should be noted that the mainstem of Hancock Creek is fenced off from cattle and fairly vegetated for most of its length. Small sections – especially along the tributaries and the lowermost portion of the creek at the confluence with Strodes Creek – do remain unfenced with degraded streambeds. It is believed that the lack of riparian vegetative and tree canopy cover, unrestricted livestock access to the stream network, and heavy grazing of riparian and upland pastures by mostly cattle on some sections of Hancock Creek and most of its tributaries contribute to increased runoff, higher stream flows, elevated loadings of bacteria and sediment, and lowered dissolved oxygen during low summertime flows. While there are some reaches of the creek that display excellent riparian vegetative cover, many areas are relatively devoid of all vegetation except grasses (see Figures 2.5-2.8 below).

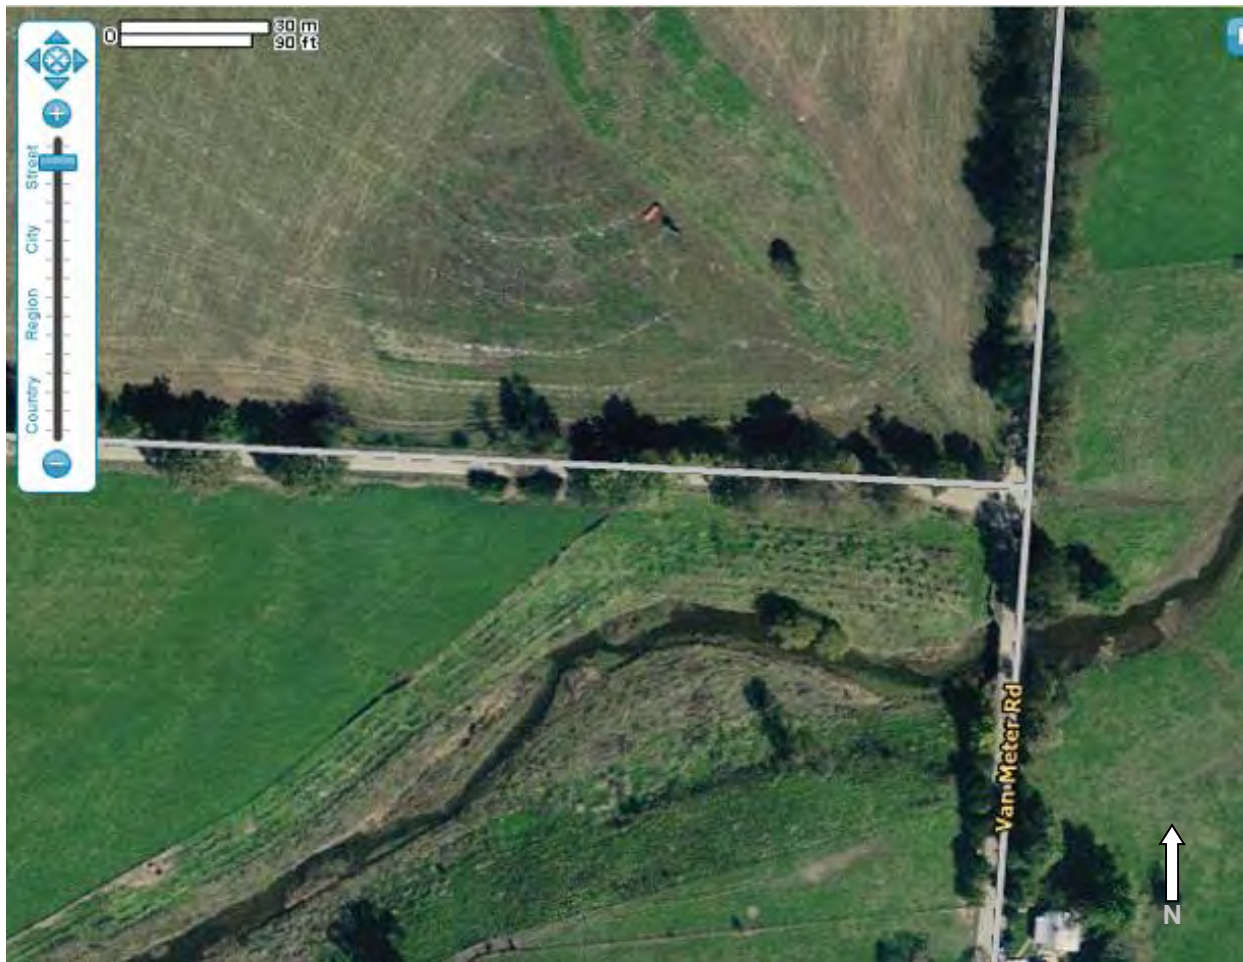
Figure 3.38: Lower reach of Hancock Creek, showing revegetated section with livestock exclusion fencing (center) and denuded banks with livestock access (right). Note variations in pasture grass density, a factor in sediment loading from sloped grazing areas. Source: Tetra Tech, 2008.

KDOW has assessed biota and supporting habitat parameters at the three monitoring stations identified in the previous section during 2004 and 2005. Aggregate scores for biota collected by the Division of Water during 2004 and 2005 were in the poor ranges, with Macroinvertebrate Biological Index (MBI) scores between 26 and 36 (note: scores below 38 are generally considered to be poor). The overall lack of instream habitat and stream bank vegetation probably contributes to the low MBI scores by 1) increasing exposure to sunlight during warm weather, causing higher stream temperatures, 2) limiting the amount and extent of instream habitat structure and refugia, and 3) increasing runoff and stream velocities during heavy storm “flushing” events. The presence of high percentages of fines (i.e., 35 to 50 percent of substrate) indicate upland and/or stream bank erosion and poor habitat conditions for macroinvertebrates. Also scoring in the poor range was bank stability and riparian vegetation.

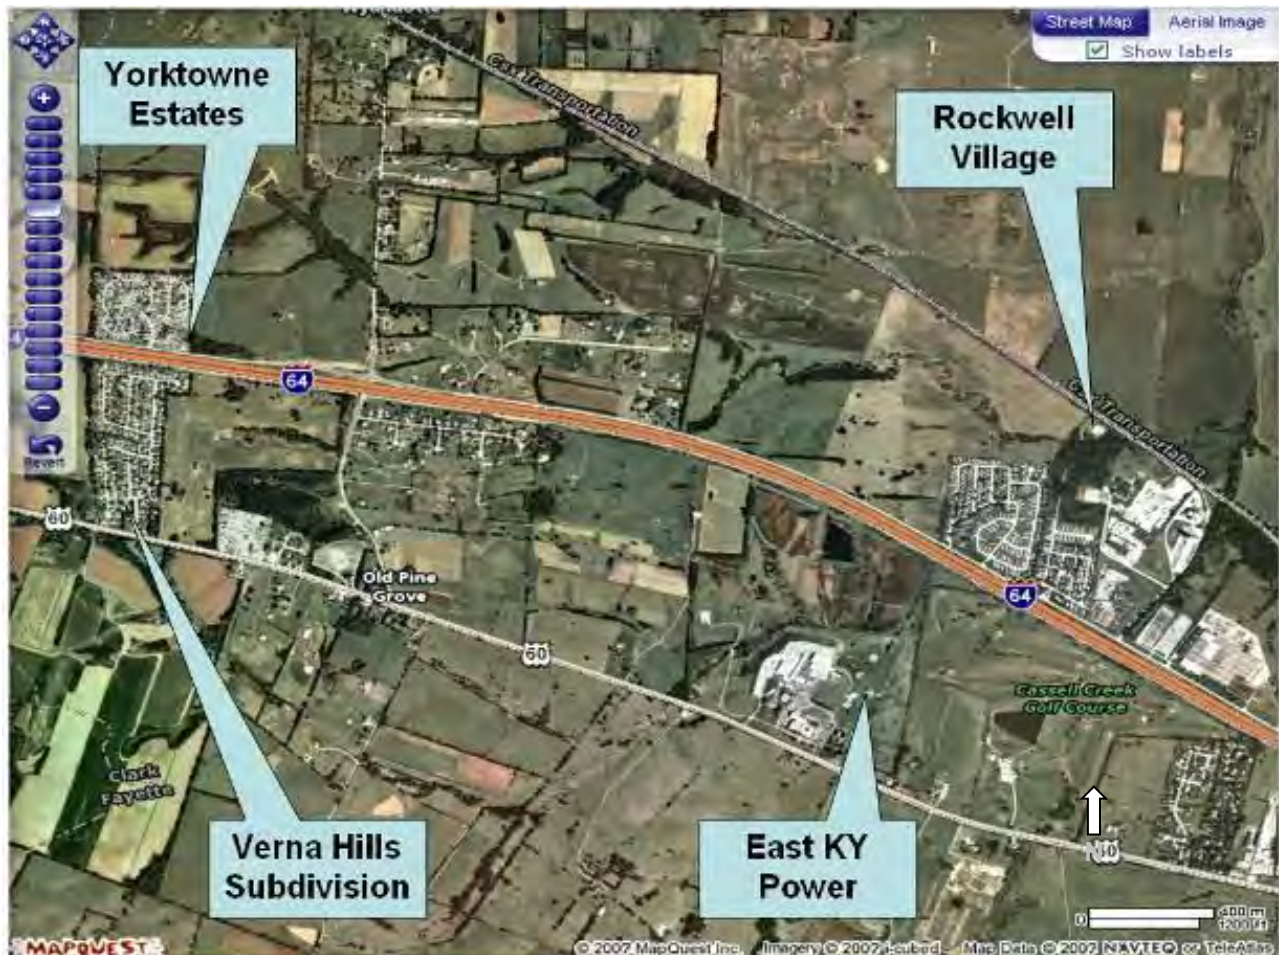
Figure 3.41: Locations of the wastewater treatment plants that discharge into Hancock Creek. Source: Tetra Tech, 2009.

For example, all three plants regularly report effluent ammonia concentrations that far exceed the numeric water quality criteria of 0.05 mg/l (Yorktowne ammonia concentrations range from 1 to 2 mg/l, Verna Hills ranges from 1 to 3 mg/l and higher, and Rockwell ranges from 0.2 to 0.4 mg/l). With summer stream flows regularly approaching zero cfs during the dry season, and only averaging 16 cfs at the confluence with Strodes Creek, it appears that high ammonia concentrations in summer effluent discharges may not be adequately diluted by the lower stream flows. In fact, all three sampling sites show high ammonia spikes during the summer sampling period (KY Division of Water Discharge Monitoring Reports, January 2006 to December 2007).

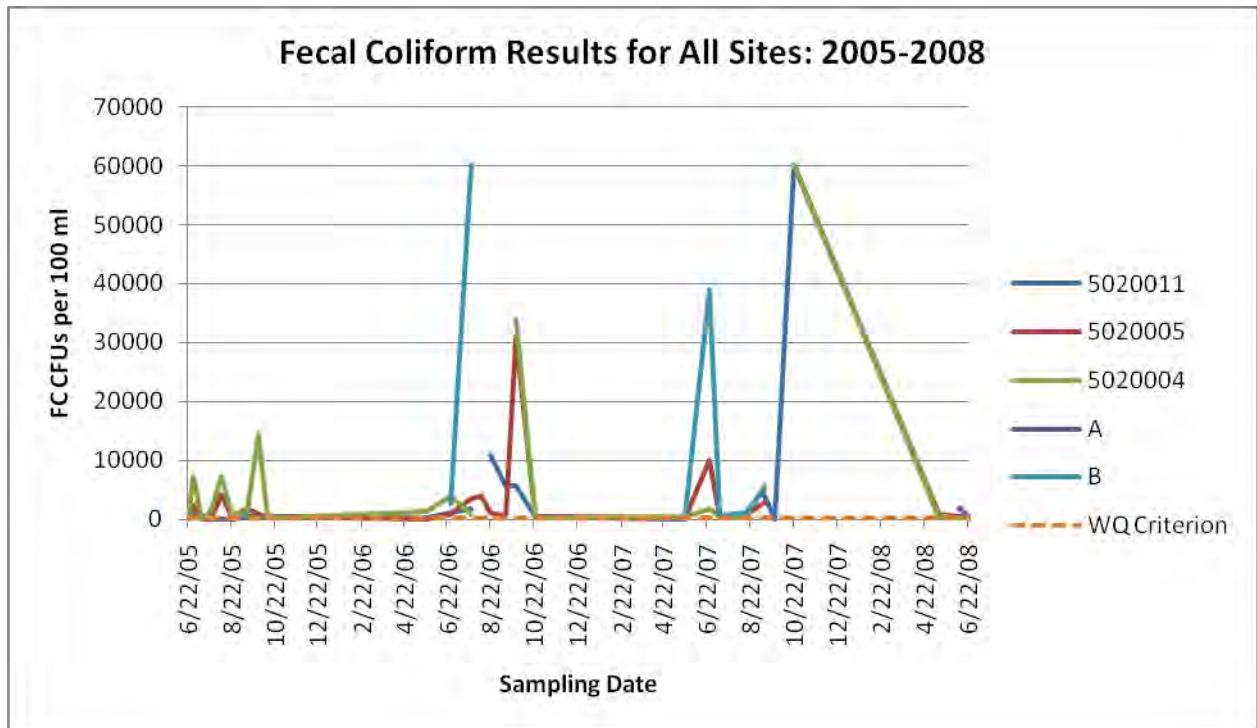
Figure 3.52: Time-series fecal coliform results for Hancock Creek sites during 2005 – 2008. Source: Tetra Tech, 2009. *Note: Data are incomplete for sites A and B.*

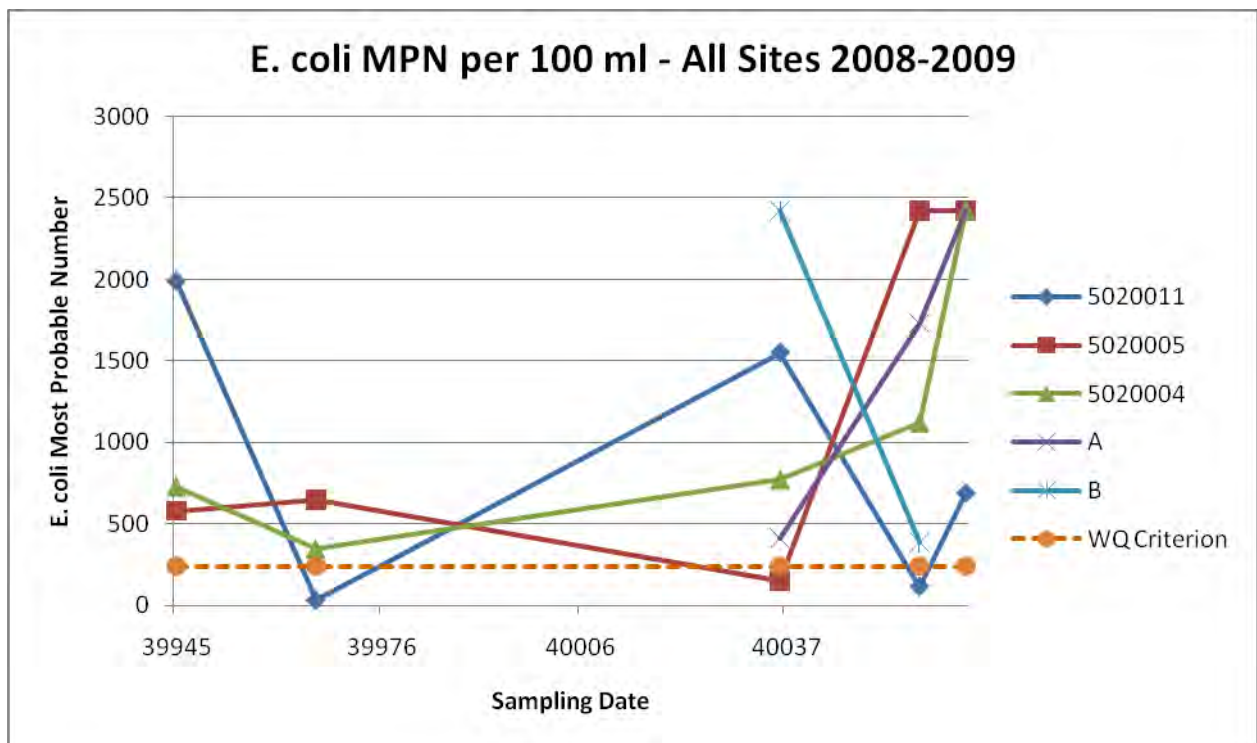
Figure 3.53: Time-series *E. coli* results for Hancock Creek sites during 2008 – 2009. Source: Tetra Tech, 2009.
