Darby Creek Watershed Plan

May 2016

Kentucky Waterways Alliance

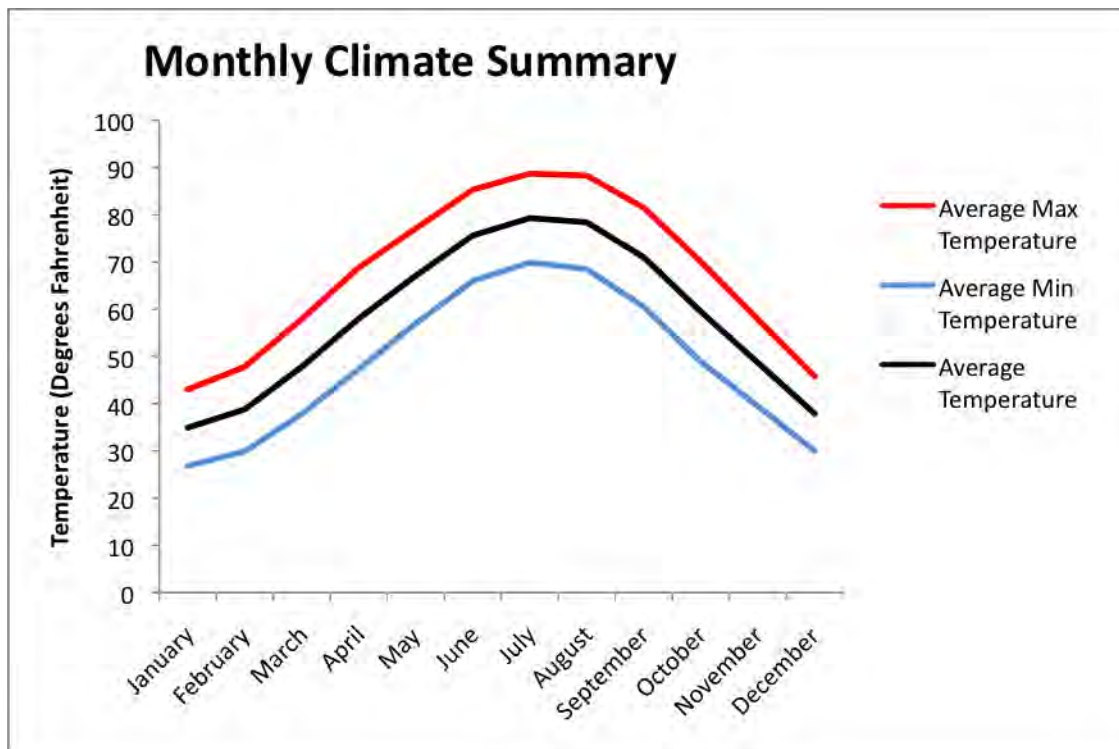
Figure 2.4: Monthly Climate Averages from 1981-2010 for Louisville area weather stations (SERCC, 2015).

Kentucky’s climate is characterized by hot and humid summers while winters are mild and cool. Figure 2.3 shows the average monthly minimum, maximum, and average temperatures from 1981-2010 for a Louisville area weather station (located in a county near the watershed of concern). The monthly average temperature ranges from 26.8° F (January) to 88.7° F (July). Annual precipitation averages 44.91 inches (monthly averages are depicted in Figure 2.4). Average monthly rainfall is highest in May with 5.27 inches and is lowest in September with 3.05 inches (SERCC, 2015).

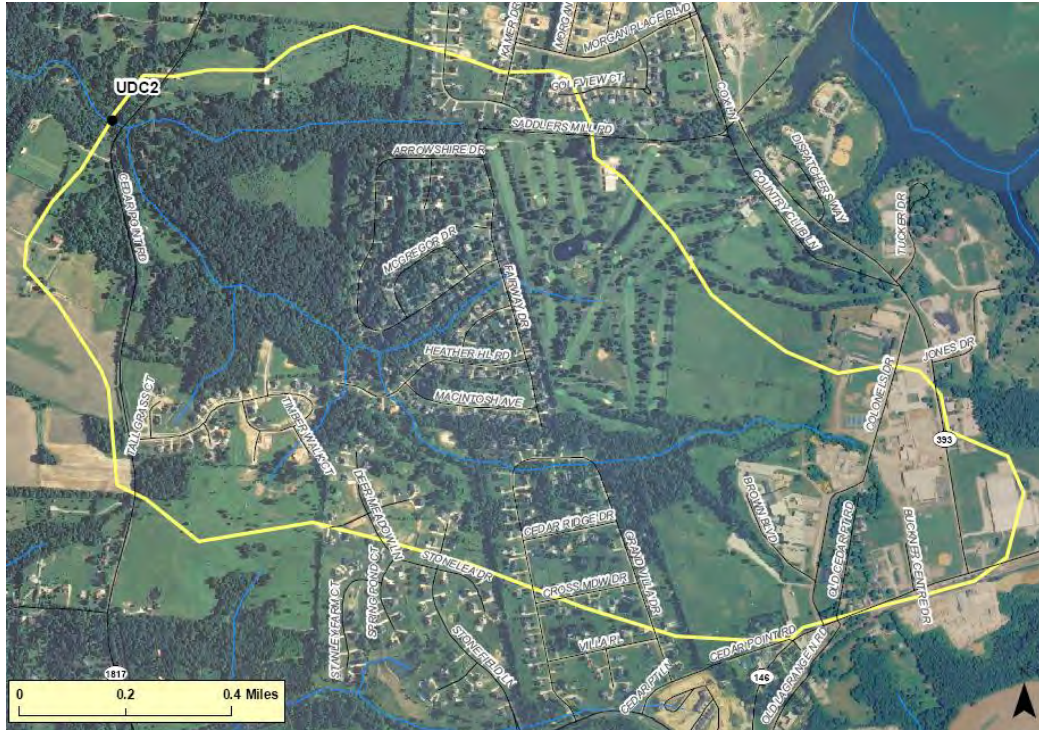
Figure 3.2: Sub-basin map of UDC2 (KDOW, 2009).

This area of the watershed is located in the east-northeast corner. Sampling results may reflect inputs from at least five tributaries (Figure 3.2)

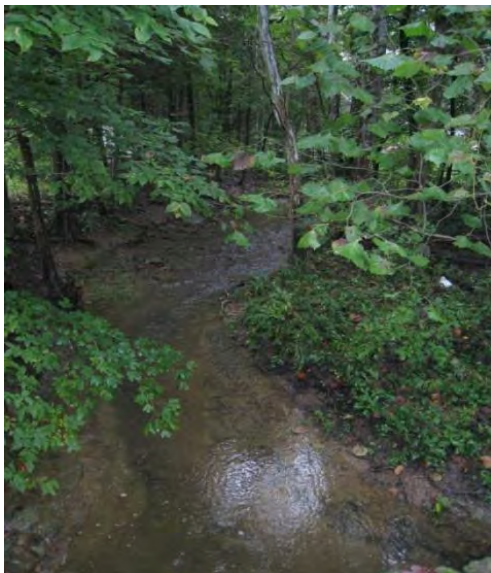
Figure 3.4: UDC2 Reach 4 (Shireman and Gessner, 2009).

- Reach 4 - Grand Villa Drive to headwaters at school complex, scored 8.2 = Good. Comments: Majority of reach was very nice. Upstream portion of stream at school is highly imperviousness and channelized.

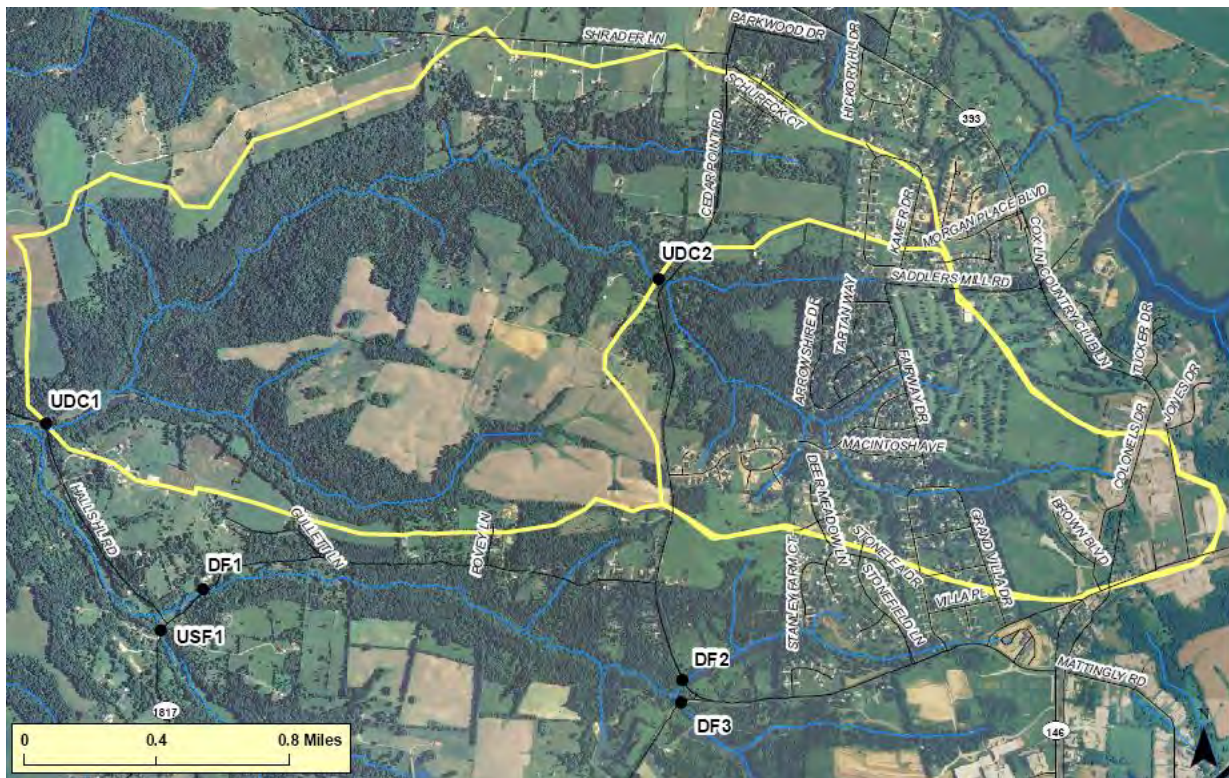
Figure 3.6: Sub-basin map of UDC1 (KDOW, 2009).

This area of the watershed is located in the central northern section (Figure 3.6). The Third Rock Consulting sampling site was directly upstream of the confluence of Darby Creek and South Fork. Sampling results reflect conditions in Darby Creek from UDC2 to the confluence with the South Fork, and inputs from four or five significant tributaries.

However, these observations only reflect conditions at the sampling site. Third Rock Consulting also reported: “This drainage reach represents the most intact/least fragmented riparian habitat in the Darby Creek Watershed.” As apparent from Figure 3.6, there are large tracts of forested land throughout the watershed.

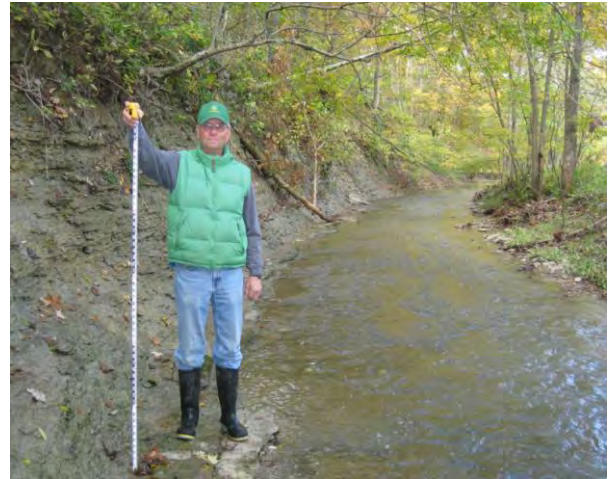
Figure 3.10: DF1 Stream walk Reach 3 (Keibler, 2009).

- Reach 3 scored 8.4 = Good. Comments: Overall nice reach of stream. One small area at beginning of reach had little riparian area and noticeable presence of livestock. This would be an excellent site for livestock exclusion. Upper portions of reach had intact riparian areas with noticeable signs of stream channel recovery. Some areas on hillsides appeared to be small dumping sites in the past.

A group of Darby Team members conducted a stream walk through this area (Figures 3.10 and 3.11). On October 12, 2009 Gary Keibler, Brooke Shireman, Margi Jones, and Jenny Howard walked a stretch of stream in subwatershed DF1, the Demptytown section. The group surveyed four reaches. The walk proceeded from west to east. To view each individual stream reach map, photos, and score sheet, see Appendix C. The reach scores are as follows:

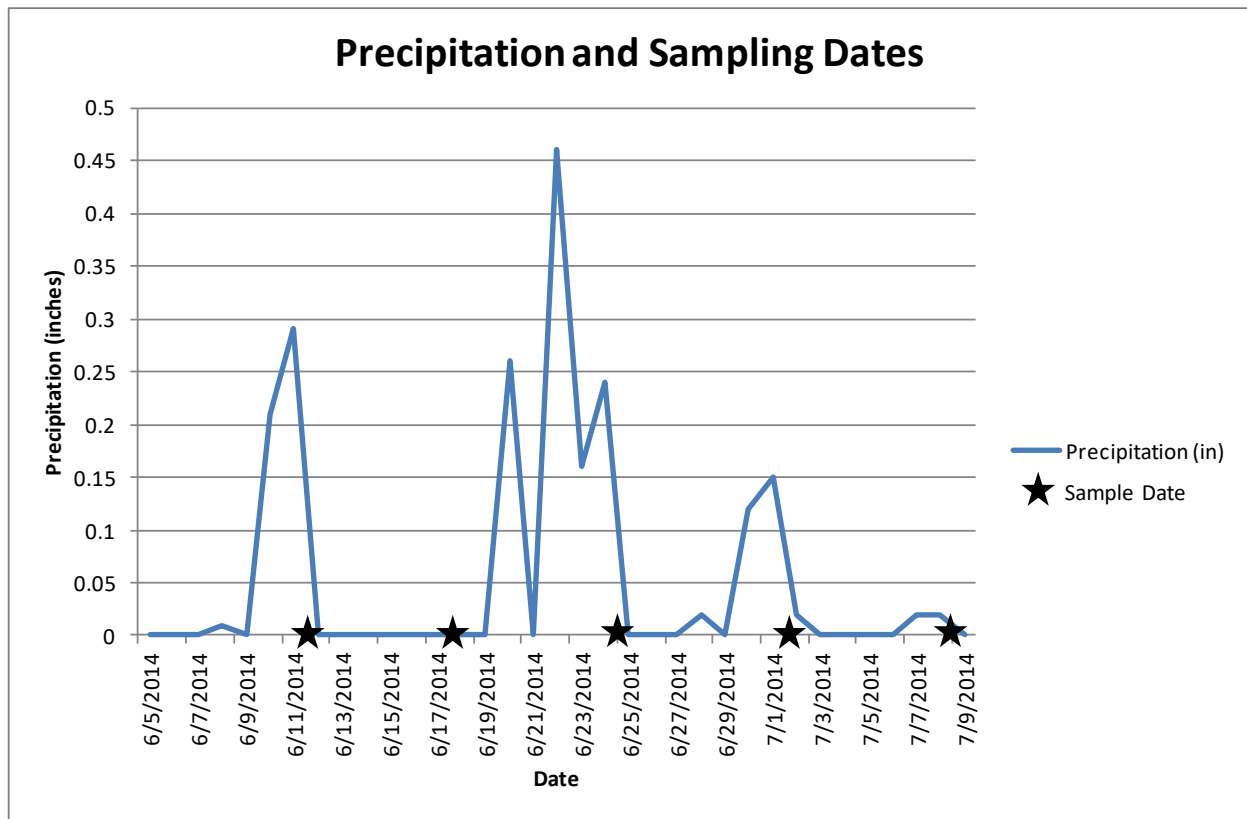
Figure 3.17: Precipitation Amounts Prior to Sampling Events.

Figure 3.17 shows the precipitation amount preceding the sampling events. The data are from Western Kentucky University’s Mesonet site and were collected at the La Grange station in Oldham County, Kentucky. Most sites show higher concentrations following rain events of 0.25 inch or more (06/12/14, 06/25/14). However, sites DOW12051008 and DOW12051004 exceeded 240 MPN/100mL for all five events.

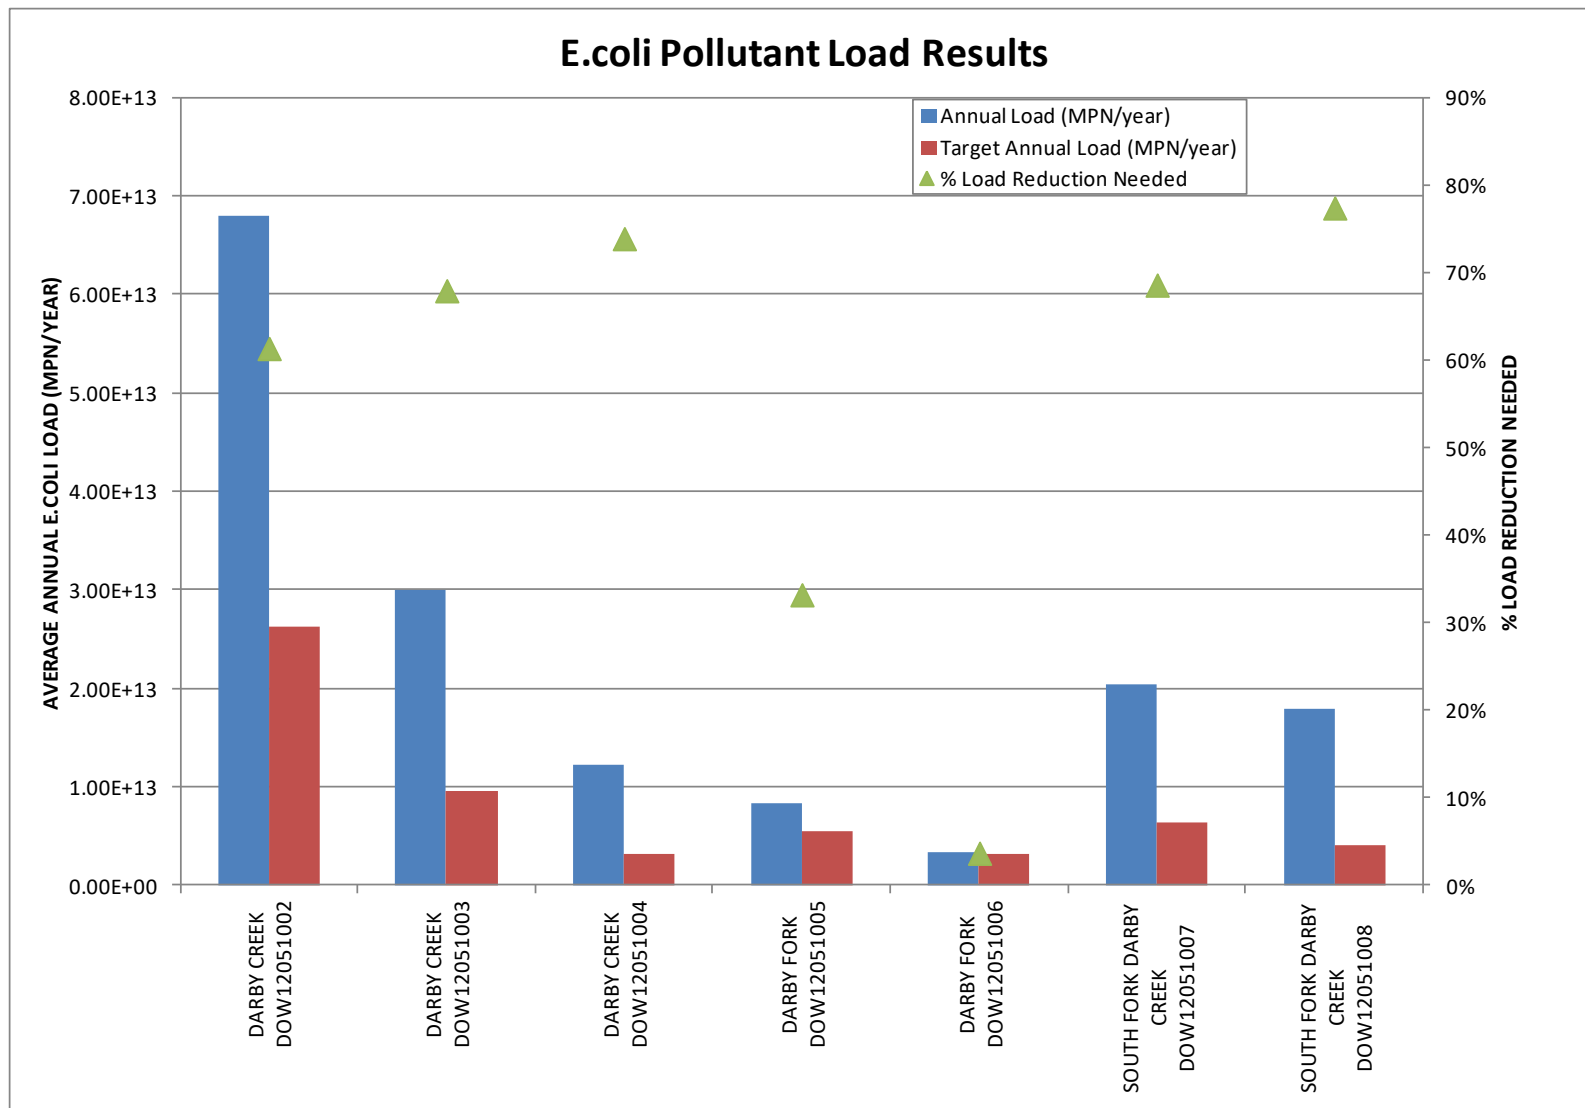
Figure 3.18: *E. coli* Pollutant Load Results from KDOW using 240 CFU/100mL PCR Standard.

EDAS #	Site Name	Average <i>E. coli</i> (MPN/100mL)	MAF (ft ³ /s)	Annual Load (MPN/year)	Target Annual Load (MPN/year)	Load Reduction Needed (MPN/year)	% Load Reduction Needed	Annual Yield (MPN/year/mi ²)
DOW 12051002	Darby Creek	621.20	12.3	6.81E+13	2.63E+13	4.18E+13	61%	6.49E+12
DOW 12051003	Darby Creek	749.20	4.5	3.00E+13	9.62E+12	2.04E+13	68%	7.95E+12
DOW 12051004	Darby Creek	920.20	1.5	1.23E+13	3.21E+12	9.09E+12	74%	9.46E+12
DOW 12051005	Darby Fork	359.40	2.6	8.32E+12	5.56E+12	2.77E+12	33%	3.95E+12
DOW 12051006	Darby Fork	249.20	1.5	3.33E+12	3.21E+12	1.23E+11	4%	2.77E+12
DOW 12051007	South Fork Darby Creek	764.60	3.0	2.04E+13	6.41E+12	1.40E+13	69%	8.14E+12
DOW 12051008	South Fork Darby Creek	1063.20	1.9	1.80E+13	4.06E+12	1.39E+13	77%	1.15E+13

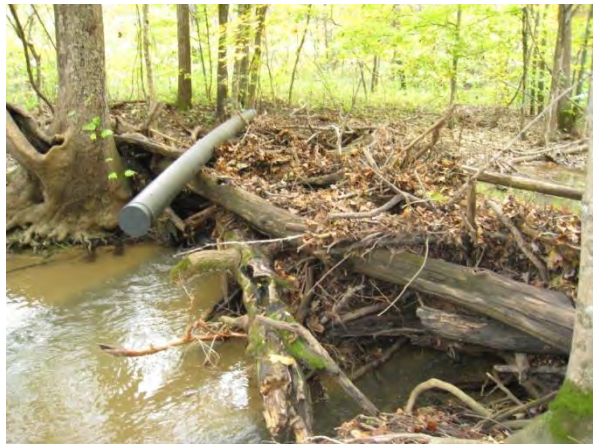
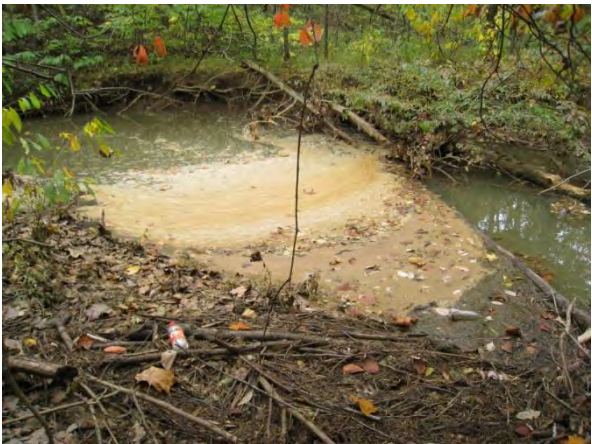
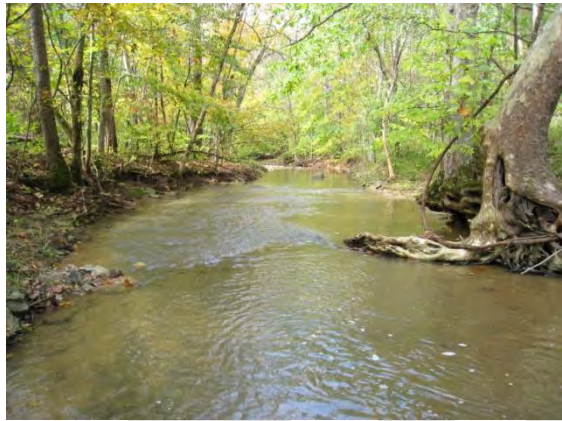
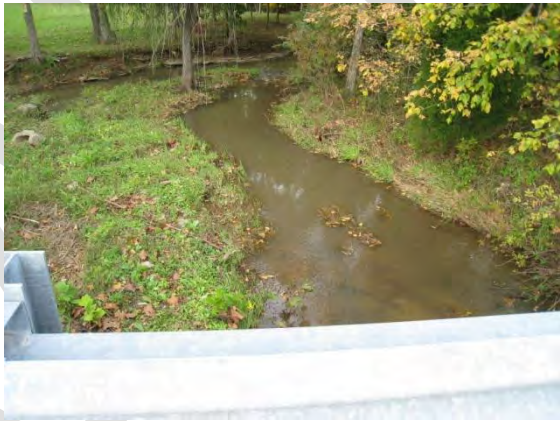
- Reach 4 scored 6.8 = Fair. Comments: Large log jam in middle of reach. Downstream from log jam – noticeable oil sheen, immediately upstream from log jam – stagnate water with brown foam. Overall bedrock bottom and more fish barriers than Reach 3.
