# Basin Retrofits & Partnerships Banklick Watershed

Kentucky Watershed Academy:  
Likely Partners

Nicole Clements  
Watershed Coordinator  
Banklick Watershed Council

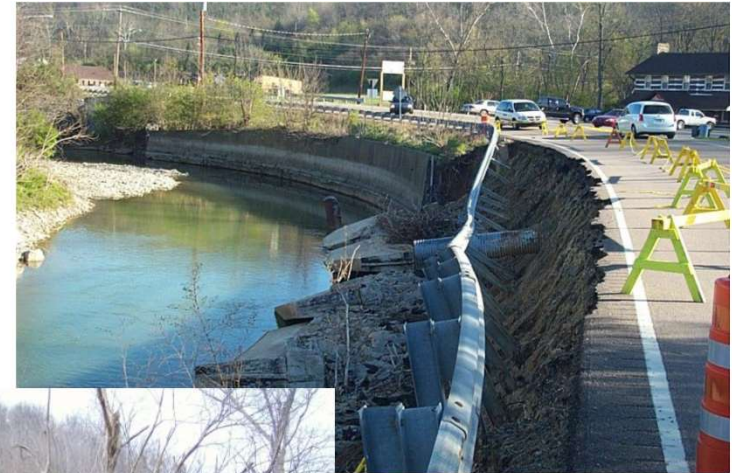
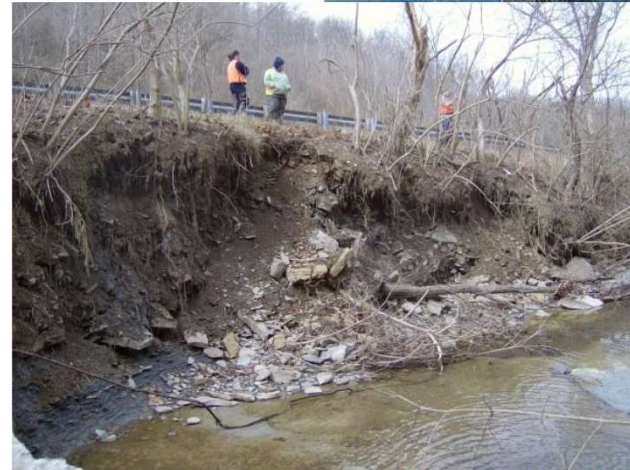
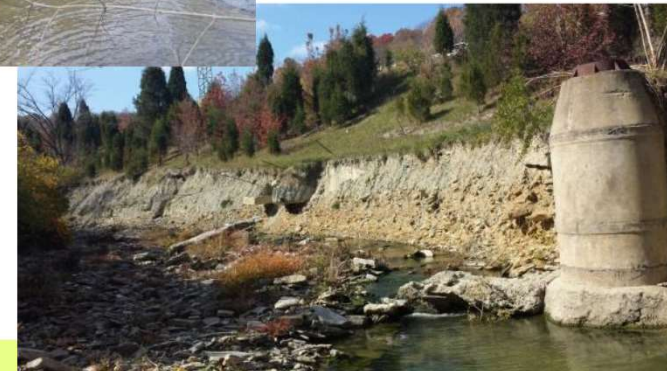
# Runoff and Erosion Threatens Infrastructure

- Channel Incision & Widening Threatening Community Infrastructure
- Impacts to:
  - Roads, Bridges
  - Utilities (Gas Lines, Water, Sewers)
- Expensive, Recurring Repairs
  - KYTC – \$3.1 Million in Damages in 2011
  - Dry Creek Watershed – \$2.6 Million in Sewer Repairs over 7yrs.

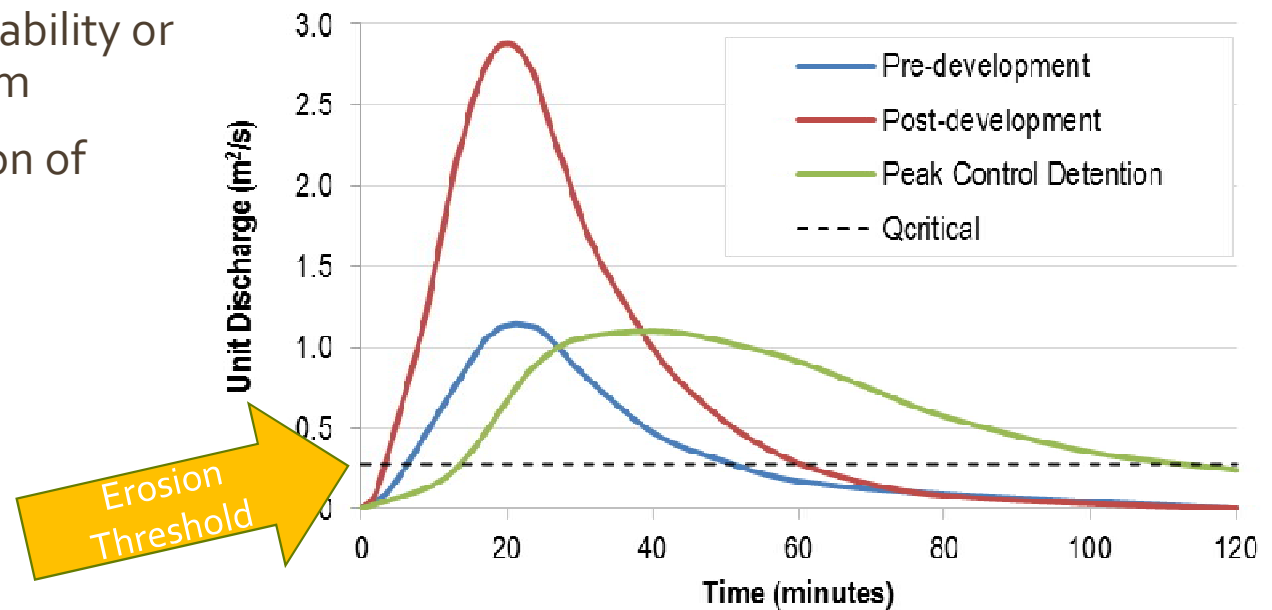
- Previously: Controls Peak Flow Rates for Large Storms to Minimize Downstream Flooding
- Does Not Address Channel Instability or Hydromodification Downstream
- Peak Control Elongates Duration of Erosive Flows

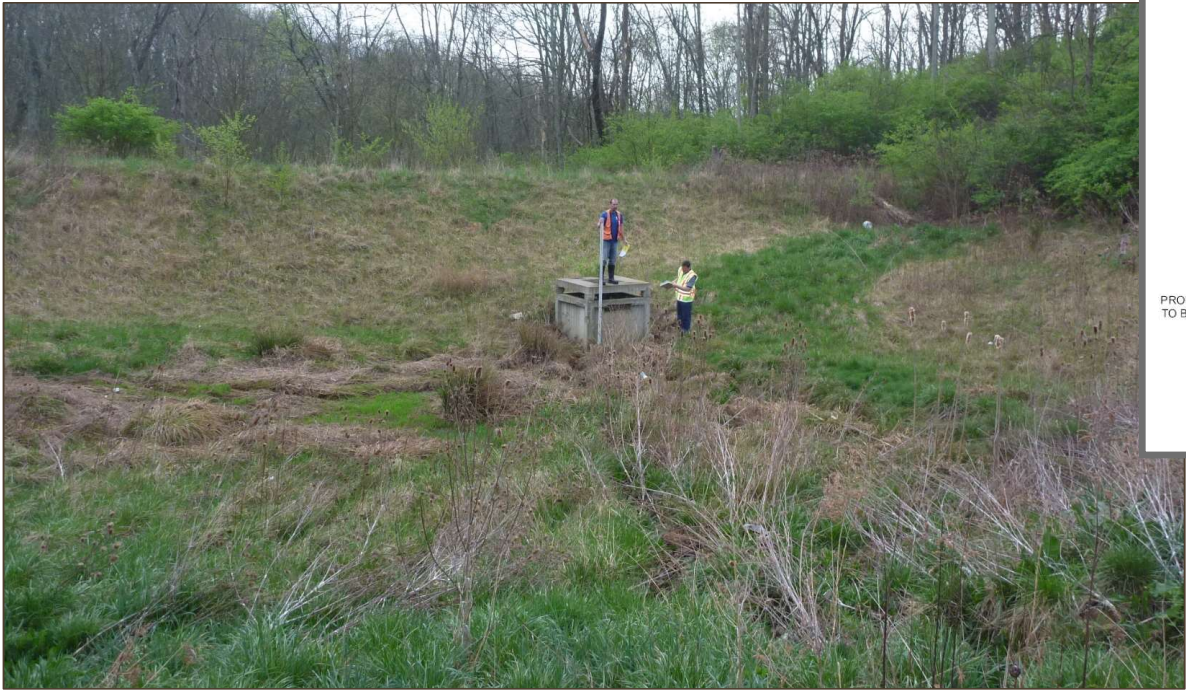
# Bioretention Retrofit Before

- Residential Area (16 acre Drainage Area)

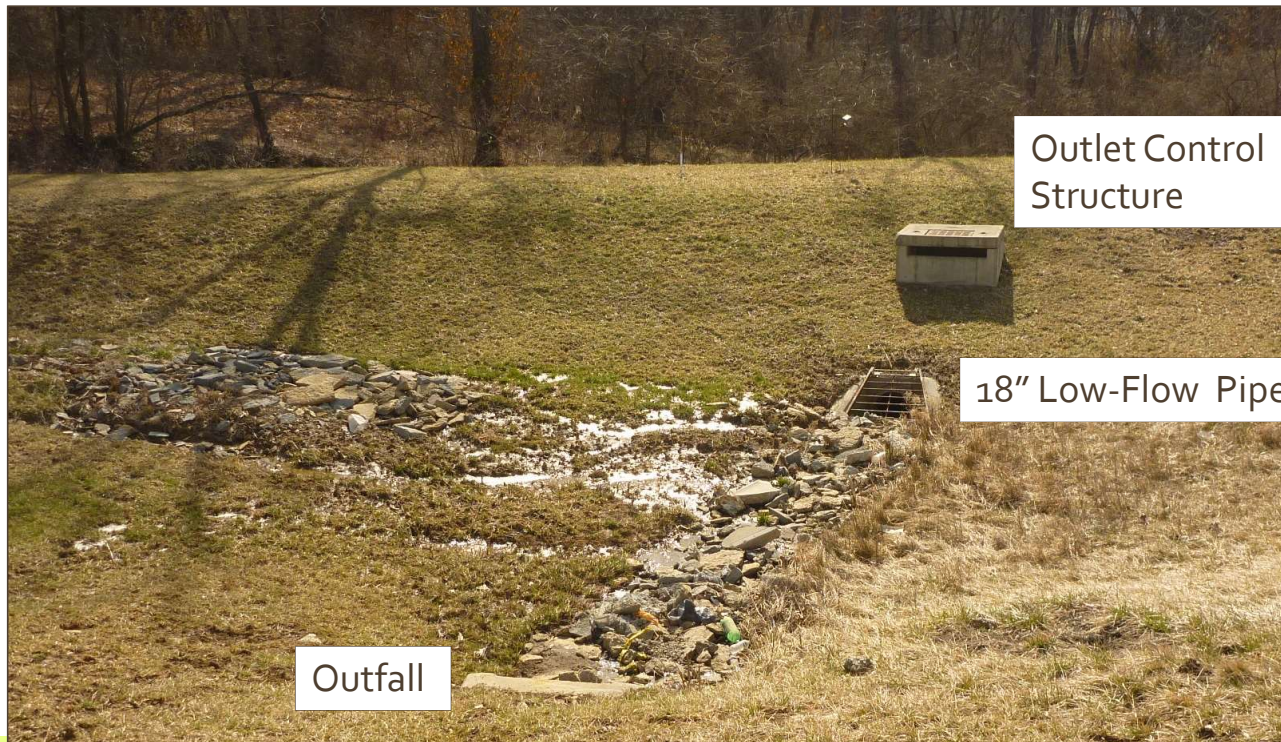
# Simplified Retrofit Before

- Residential Subdivision – ~10 Acre Drainage Area

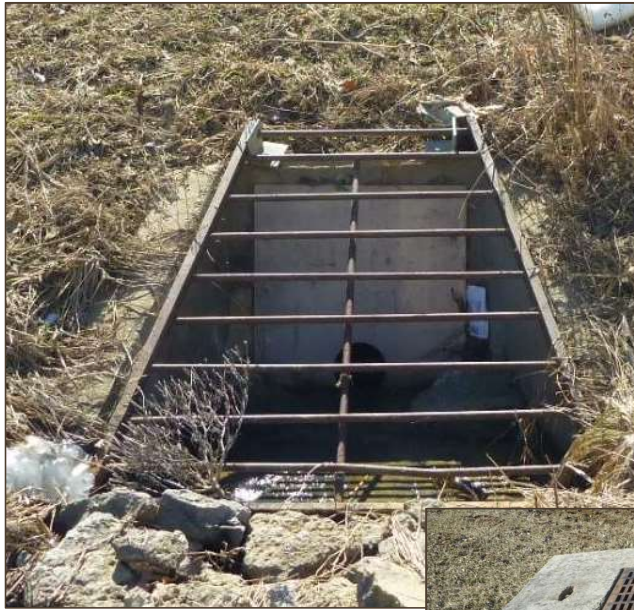
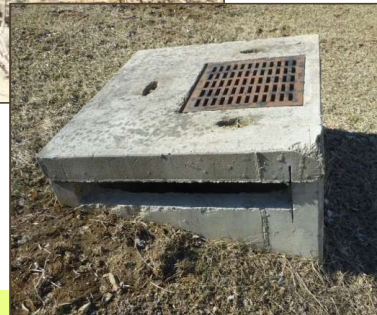
# Simplified Retrofit

After - \$4,000

- **\$4,000**
- Flows (3-Month Event)
  - Post-Development (As Built) = 4.97 cfs (+4%)
  - Post-Development (Retrofit) = 1.66 cfs (-65%)
- Sediment Transport Model
  - Pre-developed 516 tons
  - Existing (w/detention) 569 tons (+10% or 53 tons)
  - Basin Retrofit 340 tons (-34%; -176 tons)

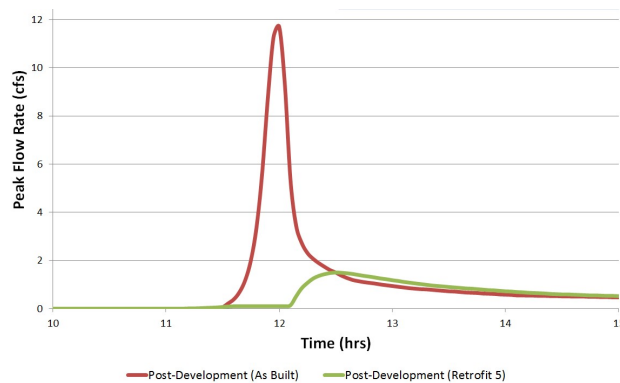
- **\$72,000**
- Flows (3-Month Event)
  - Post-Development (As Built) = 11.71 cfs (+245%)
  - Post-Development (Retrofit) = 2.47 cfs (-27%)
- Sediment Transport Model
  - Pre-developed 68 tons
  - Existing (w/detention) 398 tons (+407% or 330 tons)
  - Basin Retrofit 225 tons (+210%; 187 tons)

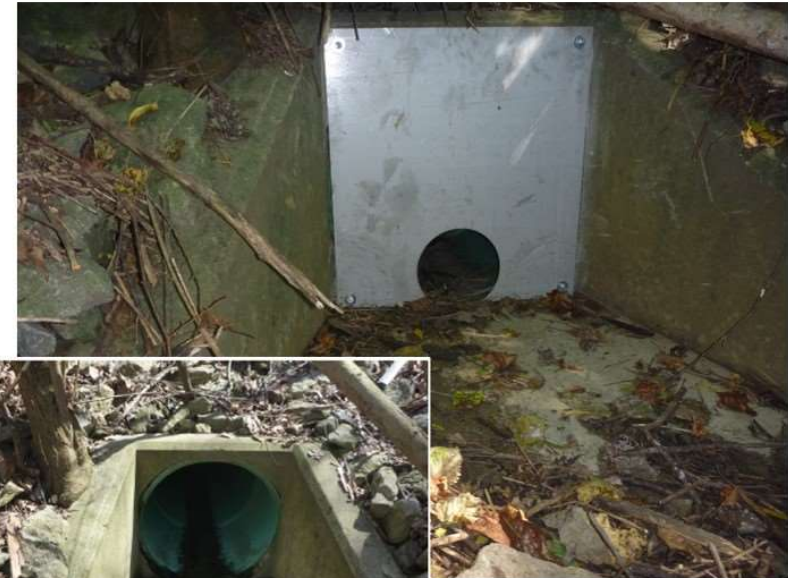
(After)

“Low-Flow” Outlet at Basin Bottom (Before)

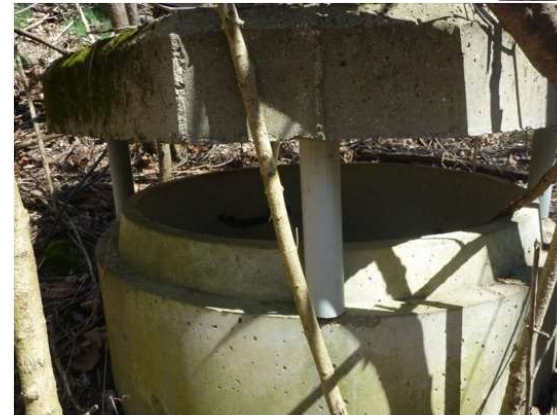
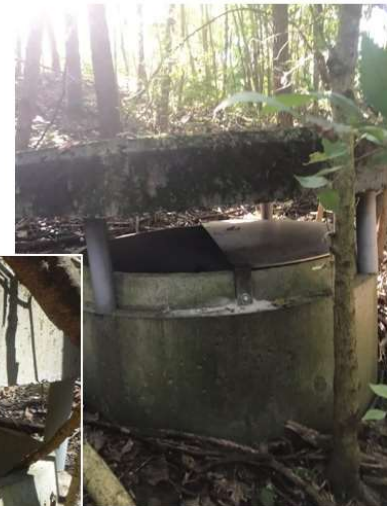
“Overflow” Structure (Before)

(After)
