Cane Run Watershed Watershed-Based Plan

Prepared for:

**The Kentucky Division of Water
300 Sower Blvd
Frankfort, KY 40601
502-564-3410**

**Third Rock Consultants, LLC
2526 Regency Road, Suite 180
Lexington, KY 40503
859-977-2000**

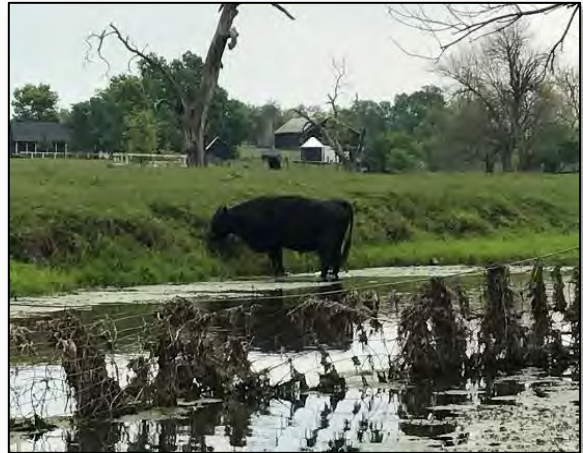
Cattle in Stream, Upstream of Site 2

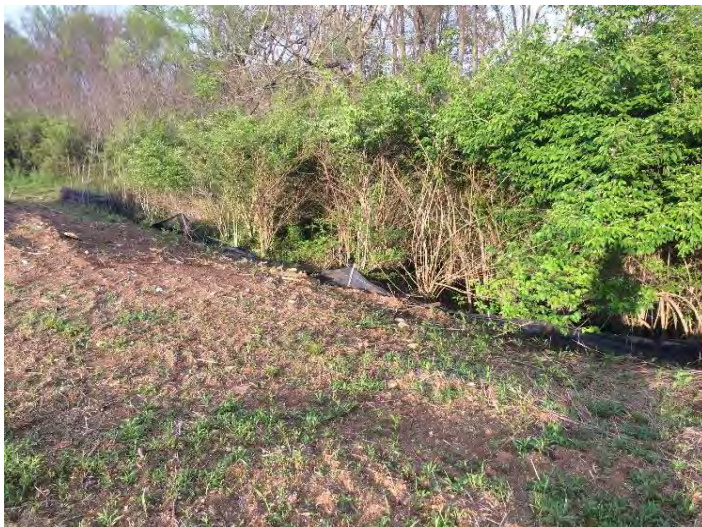
A2- Erosion Control on Rb of Reach
